## Home Inspection Report

123 Sample Buyer's Report  
Youngsville, NC 27587

Inspected By: Stephen Pait, CMI- Lic # 4329 &  
Septic Lic #72451

Inspected On Mon, Sep 25, 2023 at 1:00 PM

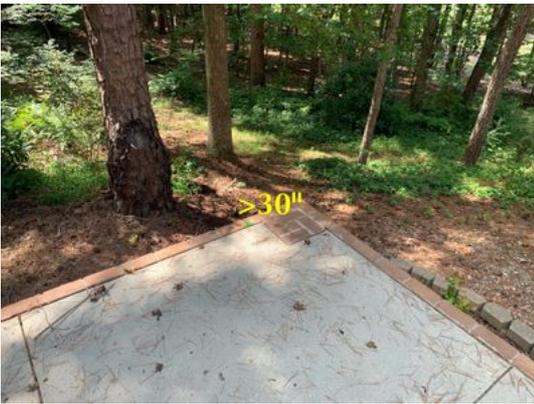
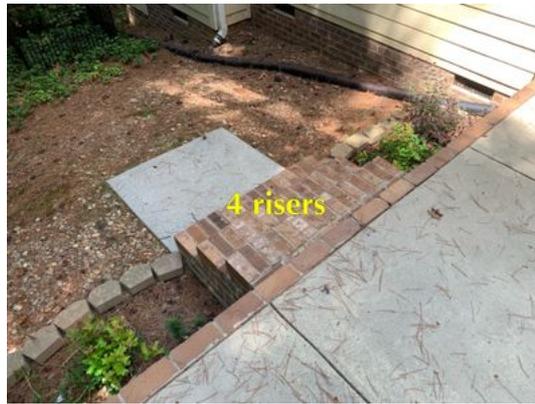
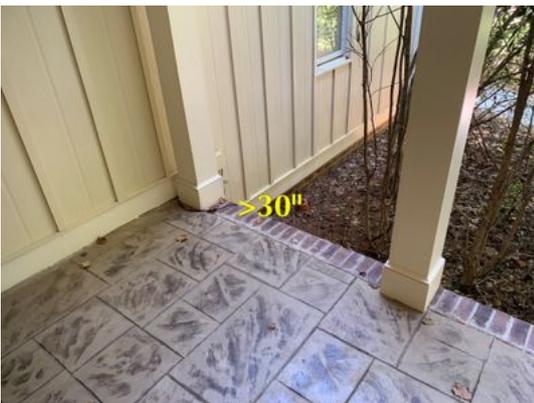
The front porch, back porch and back porch steps lack proper guardrails and a graspable handrail. Building guidelines require that every open portion of a stair, landing, balcony, porch, deck, ramp or other walking surface which is more than 30 inches above the floor or grade below shall have guardrails with spindle/baluster spacing no greater than 4" apart. Any stair system with 4 or more risers is required to have a graspable hand rail. The bottom stair riser is greater than allowed by building requirement. This is a fall safety hazard and installing guardrails with a graspable hand rail on each side is recommended.

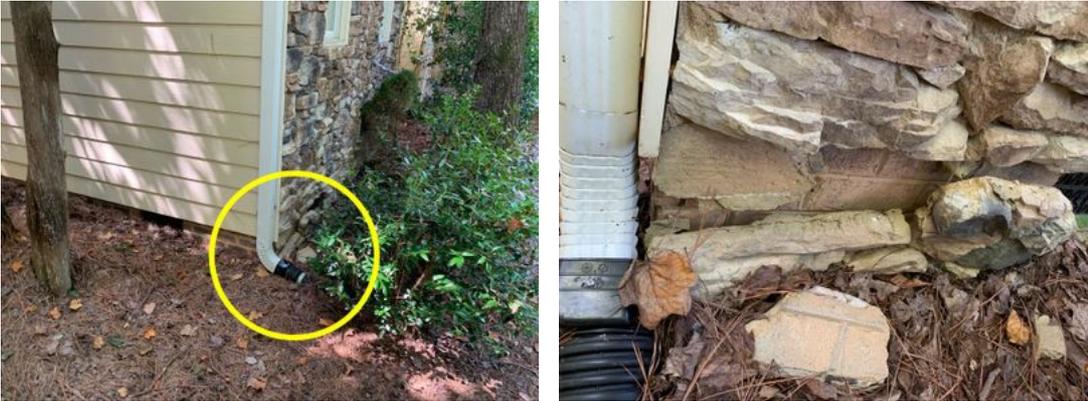
A section of stone veneer has become detached/on the front right left of the home. Repair is recommended by a qualified masonry contractor. The stone is detached on the foundation wall. Therefore, there is no risk of water entry at this location.

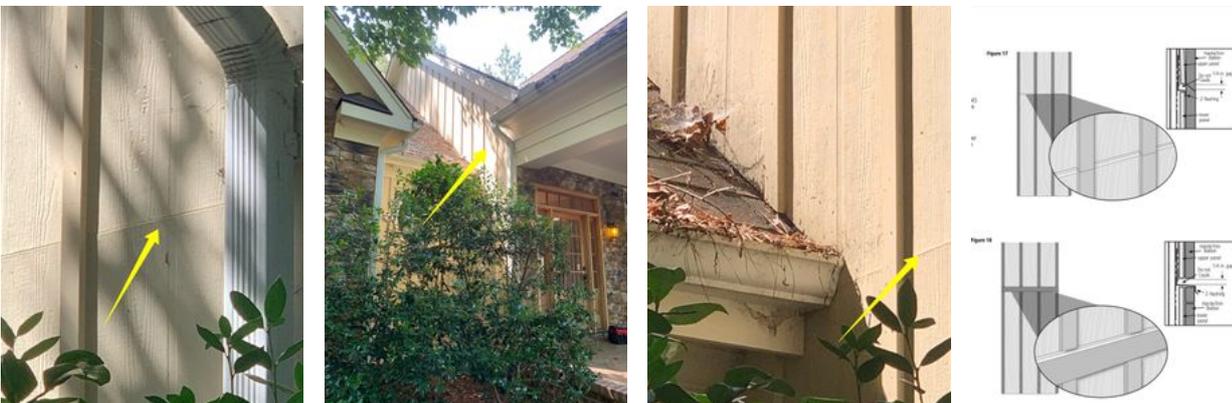
The fiber cement panels, installed on the exterior gable walls lack Z-flashing at the band board. The manufacturer requires a-flashing to be installed at all horizontal joints to prevent possible water entry into the seam. Properly installing Z-flashing is recommended.

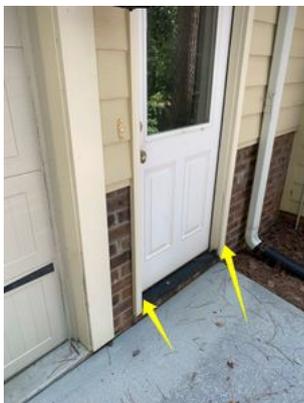
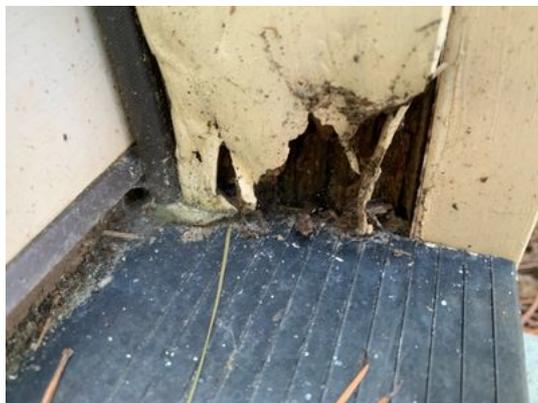
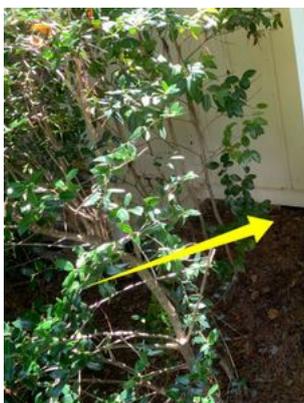
The garage entry door jamb and corner trim to the left of the front door had moisture damage. Repair is recommended by a qualified professional to prevent additional moisture entry and further deterioration or possible water entry. .

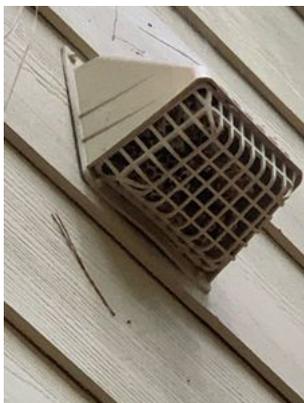
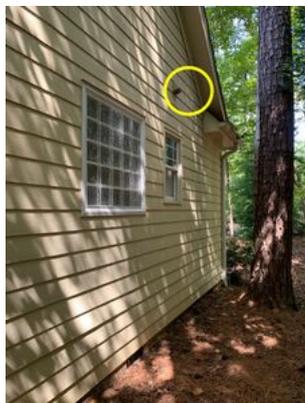
The damper on the left front exhaust vent is missing and should be replaced to prevent pest entry. The vent was full of wasp nests. Repair is recommended by a qualified contractor.

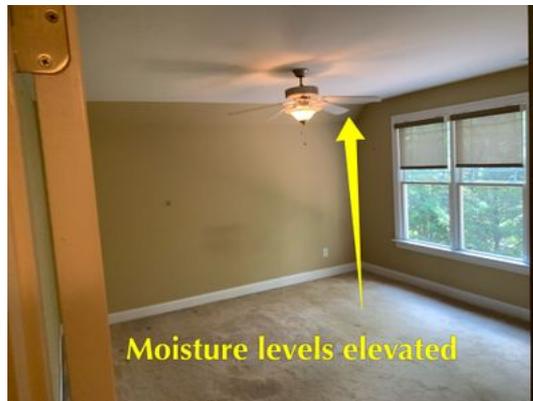
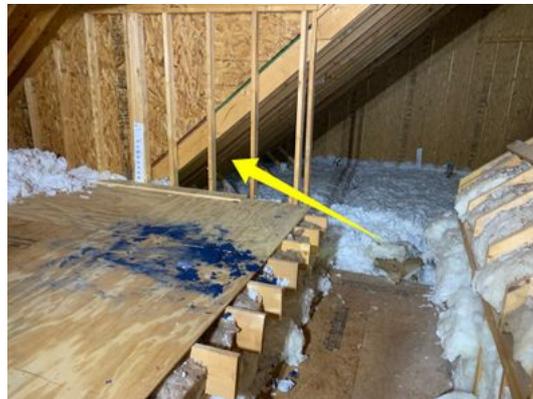
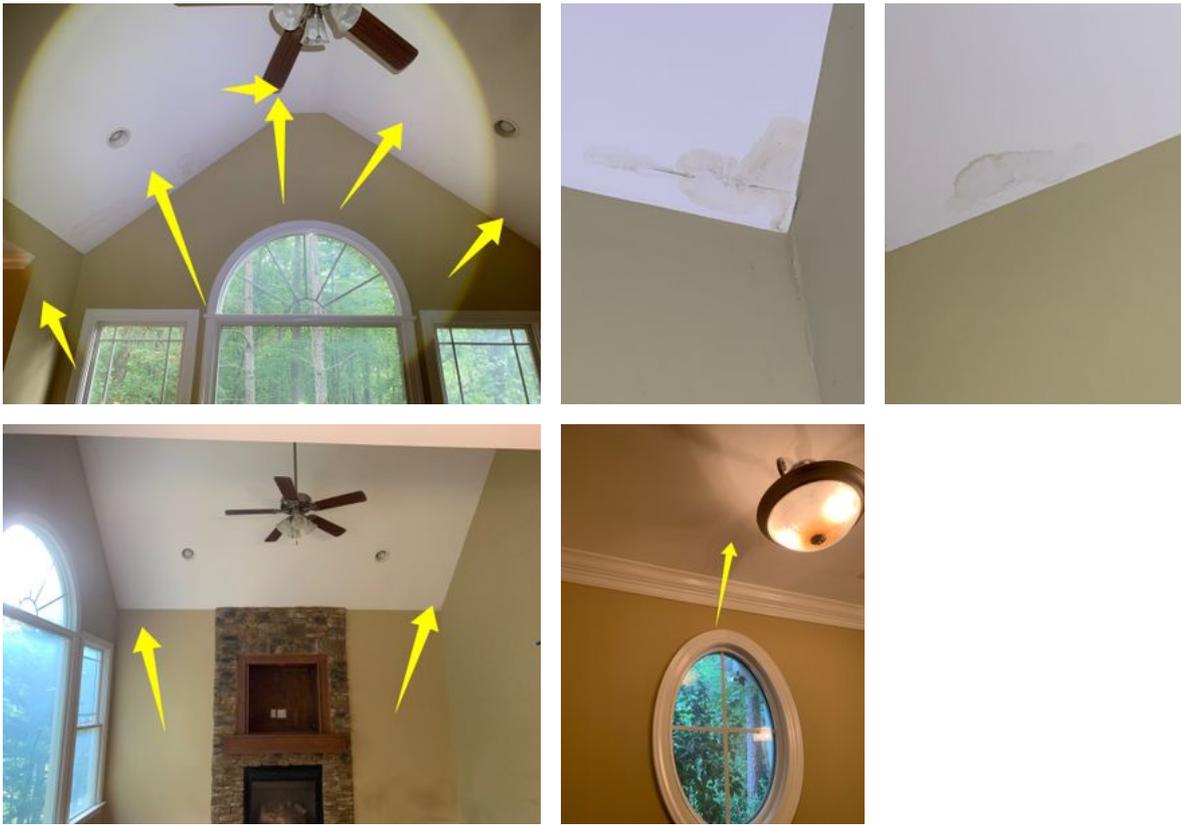
A license roofing contractor is recommended to perform a full evaluation of the roof, covering due to active leaks and multiple moisture stained areas of the ceiling observed at the time of the inspection.

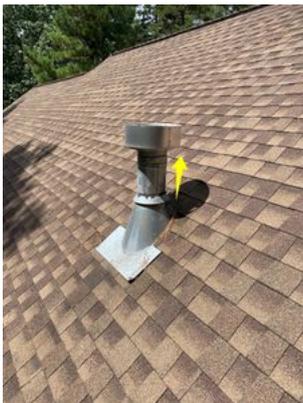
The gas fireplace vent does not have the proper clearance from the roof covering per building guidelines. A qualified fireplace contractor is recommend for evaluation and repair.

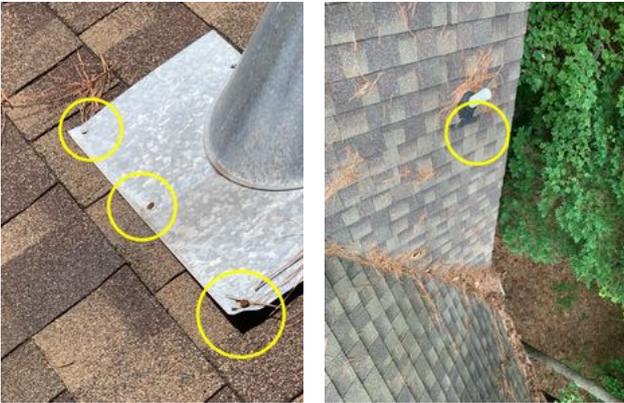
Exposed fastener heads on the roof could lead to water intrusion and damage to surrounding components. Seal all exposed heads with the appropriate roofing sealant.

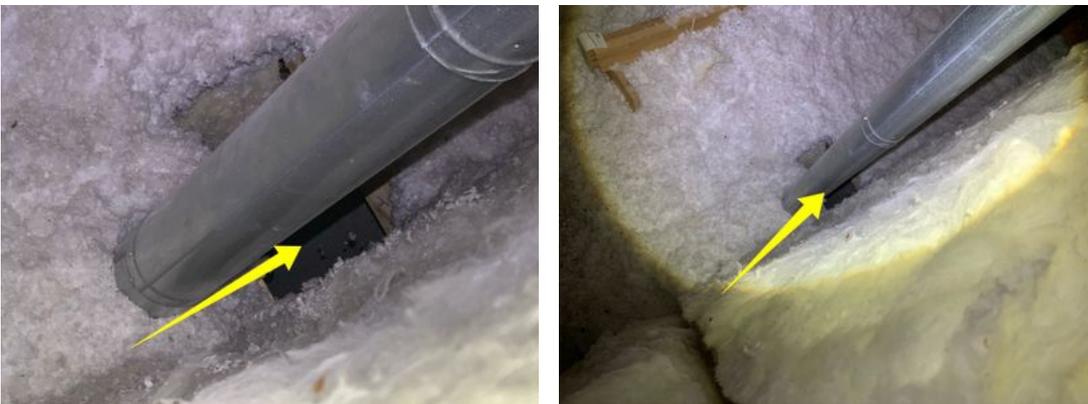
The metal chimney chase, where it penetrates the attic, requires a draft stop or thimble. This is required to reduce debris entry, conditioned air loss, and is used as a fire stop. Repair by qualified fireplace technician is required.

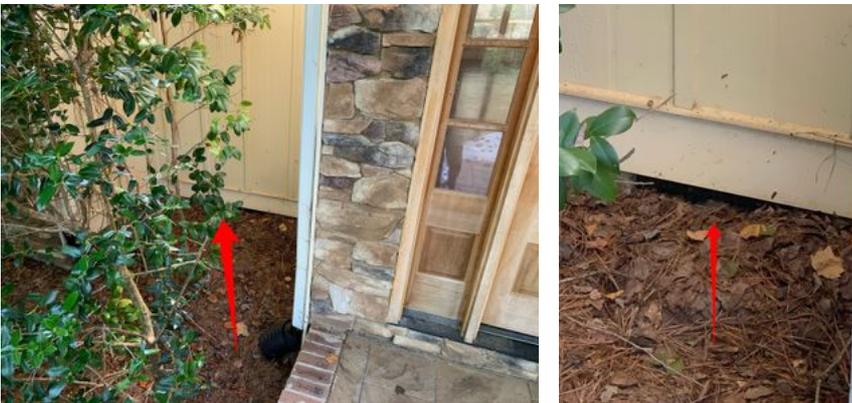
The foundation vents at multiple locations are below the exterior grade. This allows water to enter the crawlspace and prevents proper ventilation. Installing foundation vent wells and properly grading is recommended.

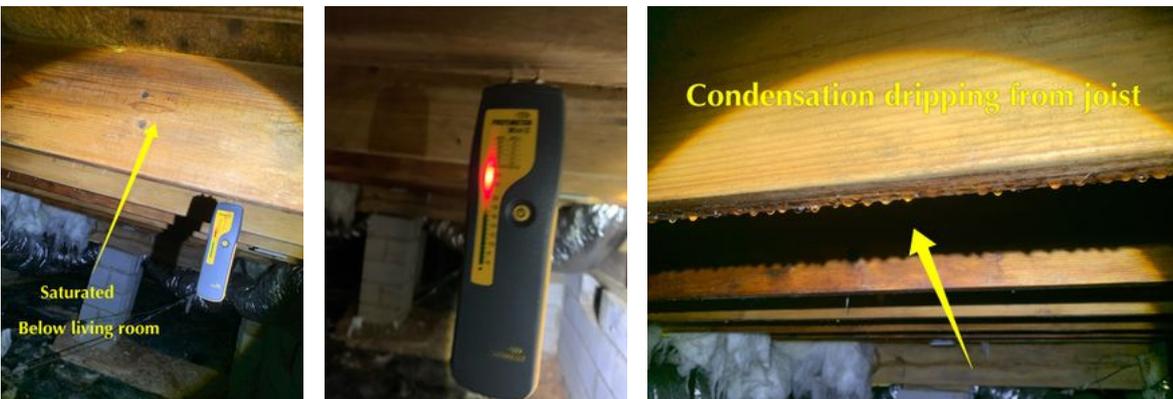
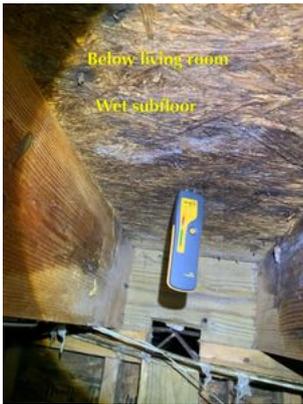
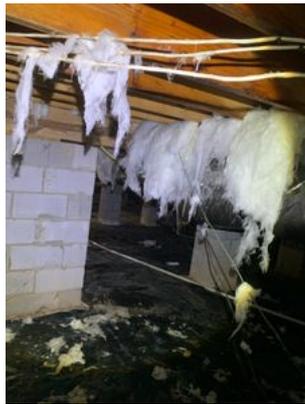
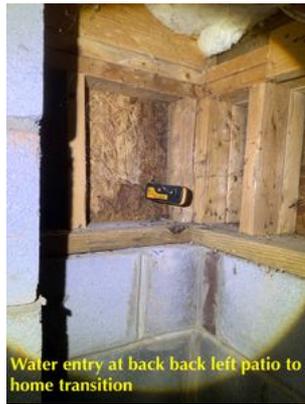
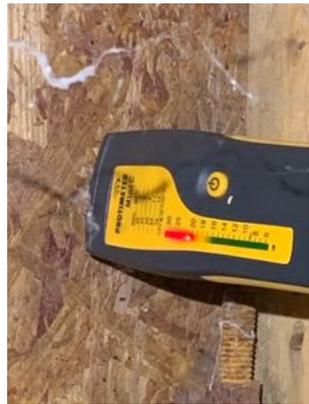
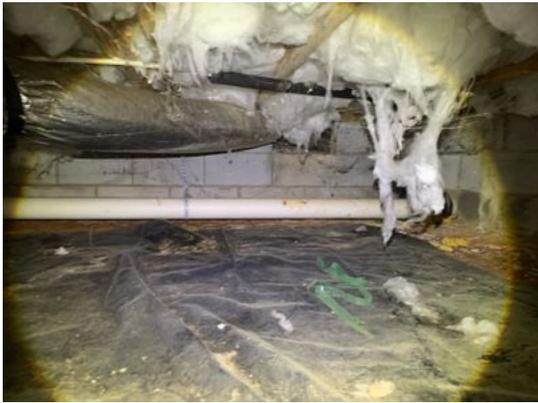
A qualified contractor is recommended to evaluate multiple areas of active water entry into the crawlspace, elevated moisture levels on the floor, structure, wet/damaged/missing insulation. An invasive evaluation is recommended to determine the extent of any moisture damage.

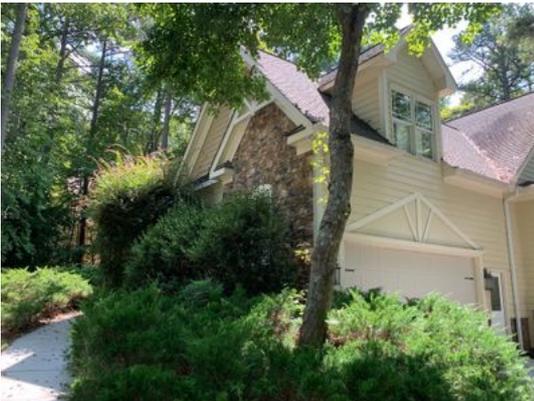
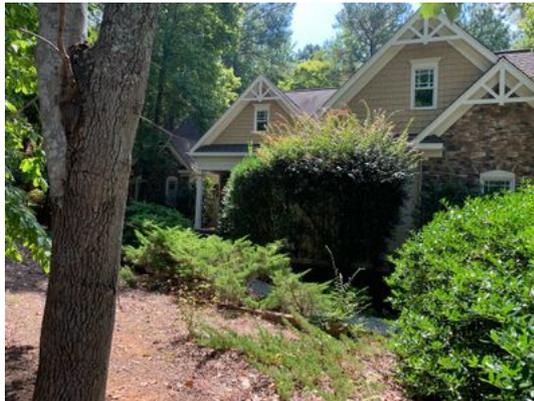
All vegetation should be cut back from the exterior cladding materials at least 12 inches to allow air movement and drying capabilities of the cladding and foundation. This helps prevent possible deterioration from excess moisture and possible foundation settlement.

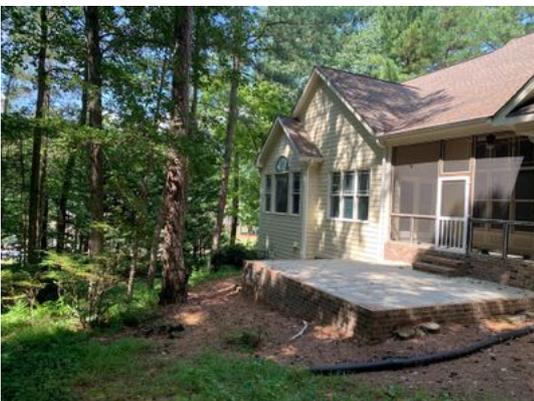
Tree roots create issues with foundations, footing and other structural elements.

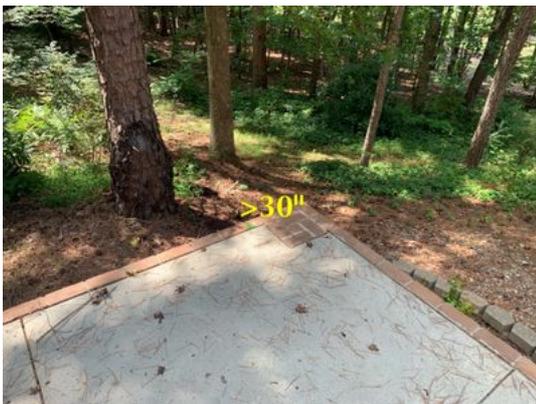
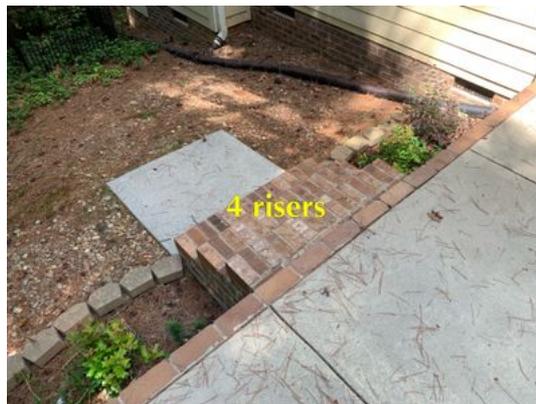
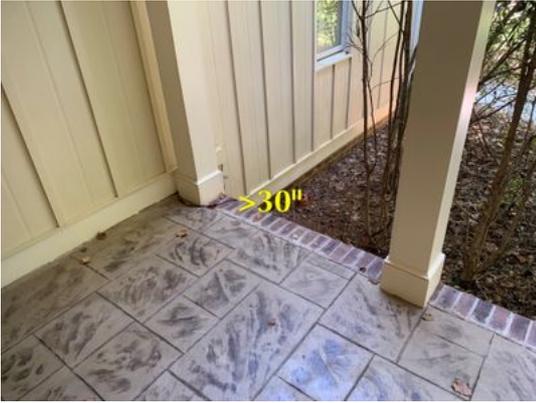
The front porch, back porch and back porch steps lack proper guardrails and a graspable handrail. Building guidelines require that every open portion of a stair, landing, balcony, porch, deck, ramp or other walking surface which is more than 30 inches above the floor or grade below shall have guardrails with spindle/baluster spacing no greater than 4" apart. Any stair system with 4 or more risers is required to have a graspable hand rail. The bottom stair riser is greater than allowed by building requirement. This is a fall safety hazard and installing guardrails with a graspable hand rail on each side is recommended.

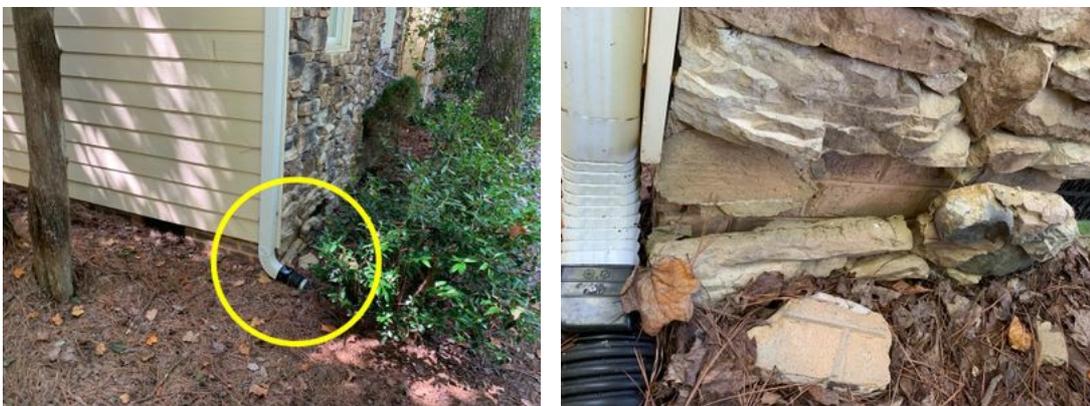
A section of stone veneer has become detached/on the front right left of the home. Repair is recommended by a qualified masonry contractor. The stone is detached on the foundation wall. Therefore, there is no risk of water entry at this location.

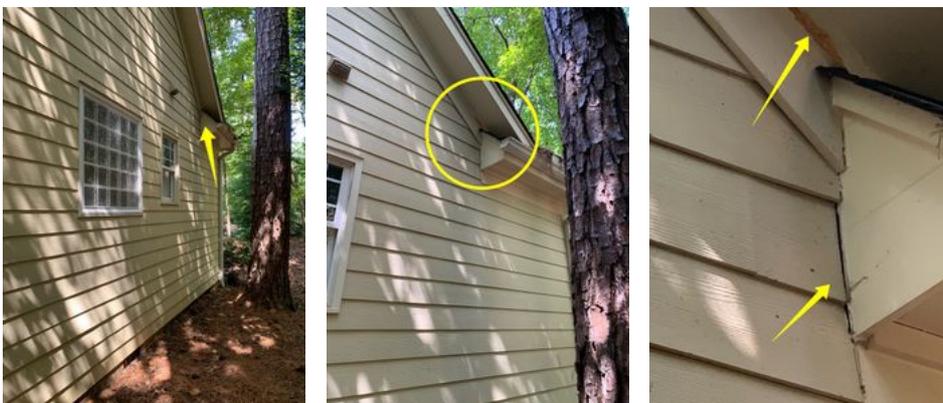
Sealing the joint between the siding and exterior trim on the left front corner of the home is recommended. Additionally, there appeared to be damage caused by pests to the frieze board at the same location and repair/sealing. The exposed material is recommended.

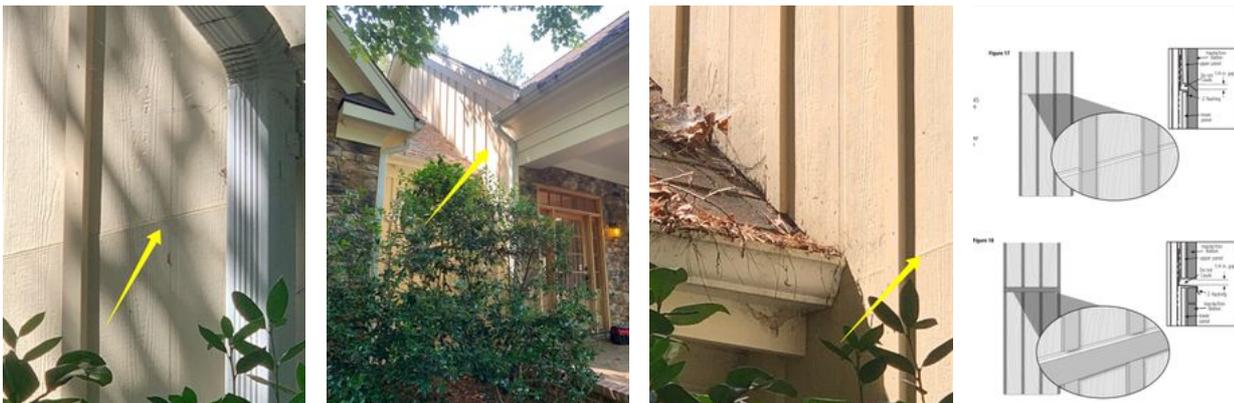
The fiber cement panels, installed on the exterior gable walls lack Z-flashing at the band board. The manufacturer requires a-flashing to be installed at all horizontal joints to prevent possible water entry into the seam. Properly installing Z-flashing is recommended.

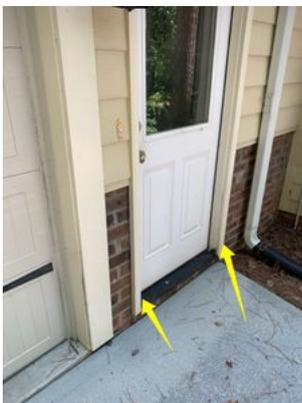
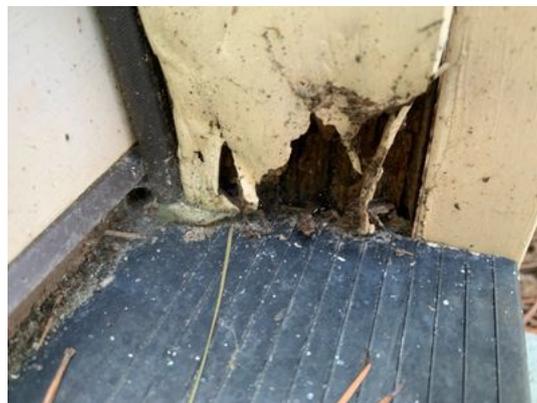
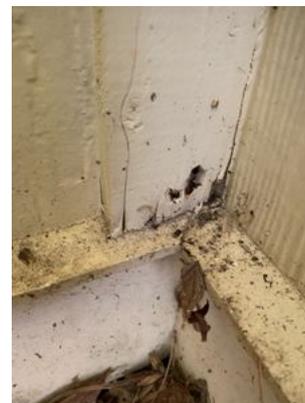
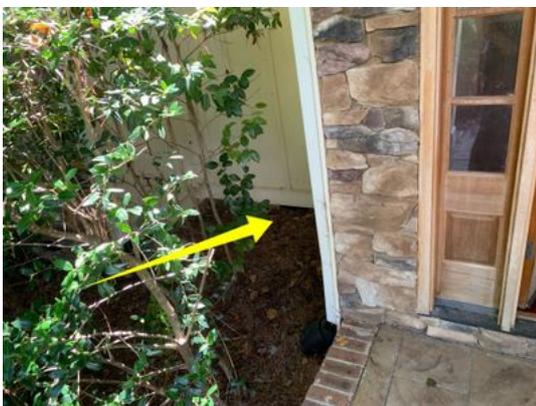
The garage entry door jamb and corner trim to the left of the front door had moisture damage. Repair is recommended by a qualified professional to prevent additional moisture entry and further deterioration or possible water entry. .

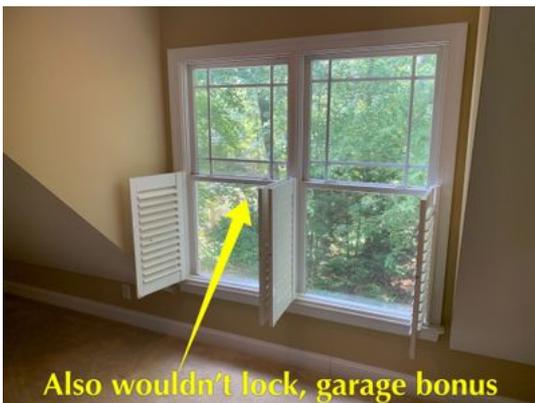
Current guidelines require any window with a sill lower than 24" to the finish floor on the interior side but is greater than 6' feet above grade on exterior side to have sash limits installed. This is a safety device to prevent children from possibly opening and falling out of the window. While it may not have been a requirement at the time this home was built, it is a safety hazard and installing sash limits is recommended. (Photo is example and may not be inclusive of all windows)

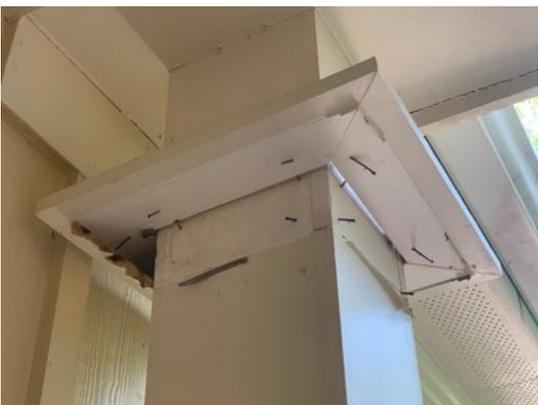
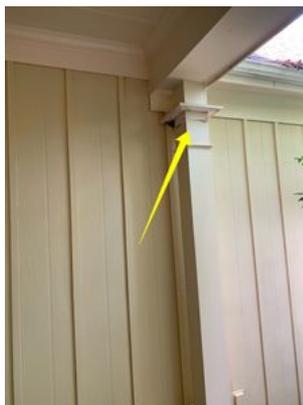
A qualified professional is recommended to repair the missing capital trim on the right front porch post. Cosmetic.

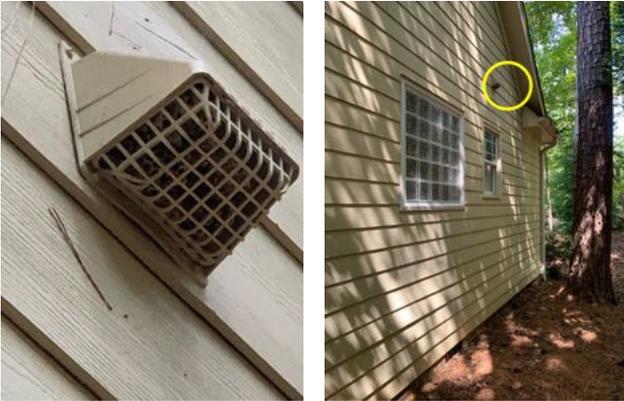
The damper on the left front exhaust vent is missing and should be replaced to prevent pest entry. The vent was full of wasp nests. Repair is recommended by a qualified contractor.

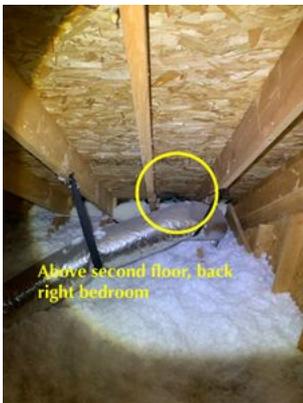
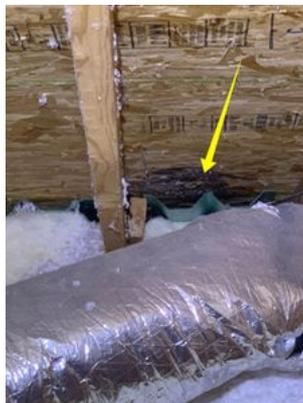
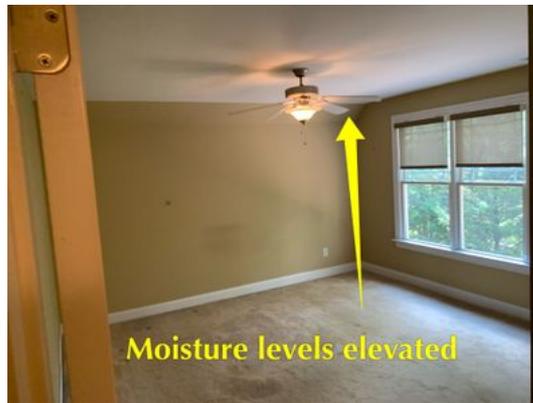
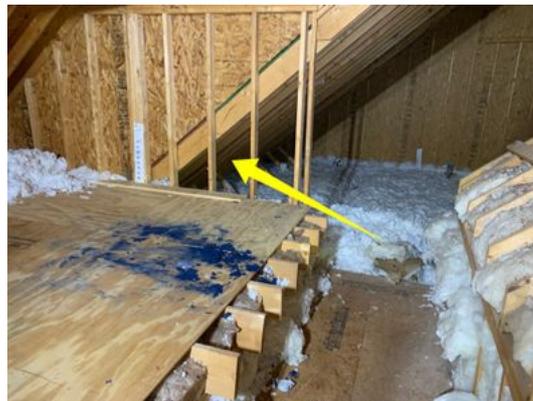
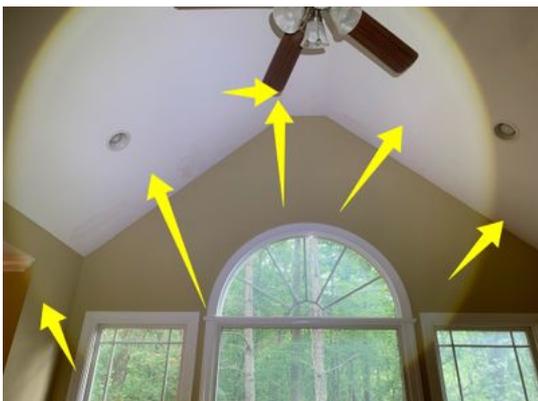
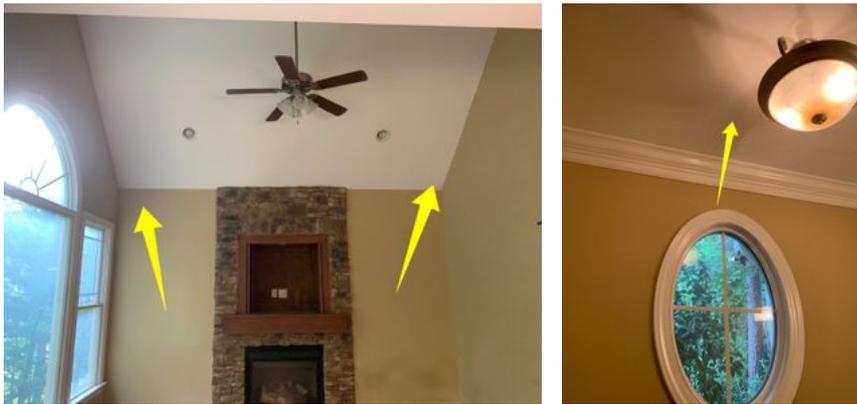
A license roofing contractor is recommended to perform a full evaluation of the roof, covering due to active leaks and multiple moisture stained areas of the ceiling observed at the time of the inspection.

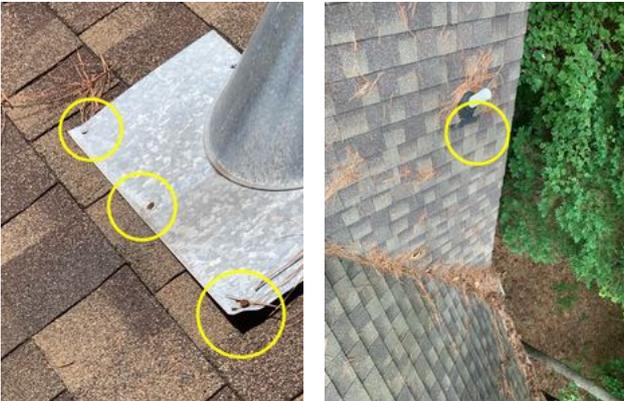
Exposed fastener heads on the roof could lead to water intrusion and damage to surrounding components. Seal all exposed heads with the appropriate roofing sealant.

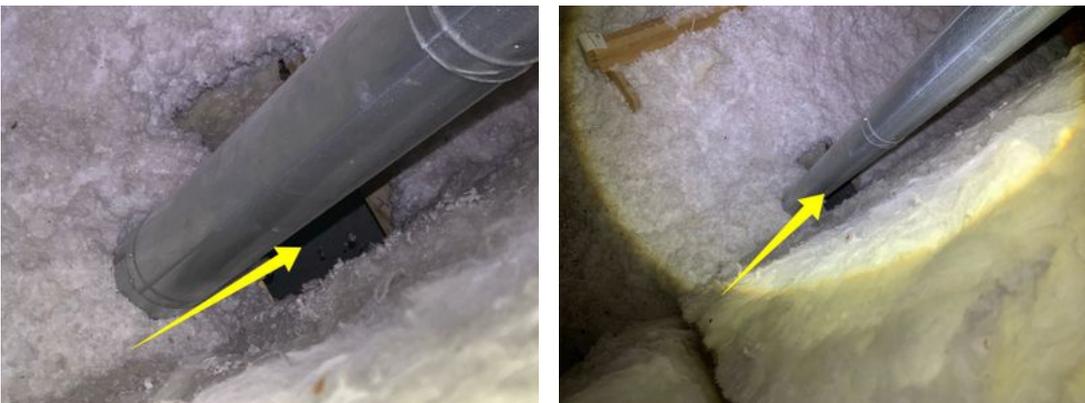
The metal chimney chase, where it penetrates the attic, requires a draft stop or thimble. This is required to reduce debris entry, conditioned air loss, and is used as a fire stop. Repair by qualified fireplace technician is required.

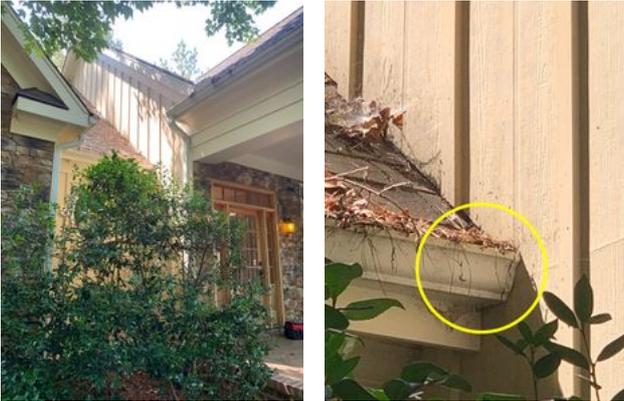
The roof lacks kick out flashing. Flashing is required to be installed where the eave of a sloped roof intersects a vertical sidewall. The kick out flashing should divert water away from where the eave abuts the cladding to prevent possible moisture entry or premature deterioration of materials. This may not have been required at the time of construction, however it is required by current building guidelines and recommended to have installed. Have a licensed roofing contractor evaluate and install proper flashing at any similar locations.

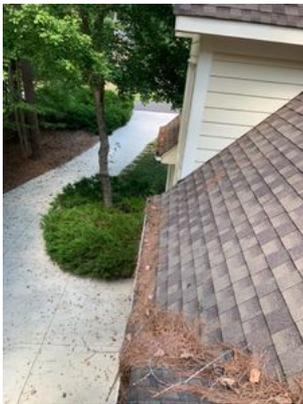
The gutters, in multiple locations, were filled with debris which will prevent water from exiting into the downspouts. This could cause water runoff in areas that could present moisture problems. Cleaning out the gutters and ensuring functional flow out of the downspouts is recommended.

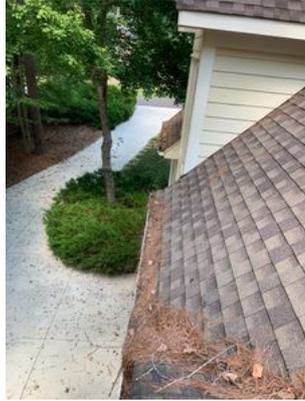
There was debris from trees and surrounding vegetation on the roof. This can allow water to back up under the roofing materials and could lead to water entry and damage to surrounding components. Removal of the debris is recommended.

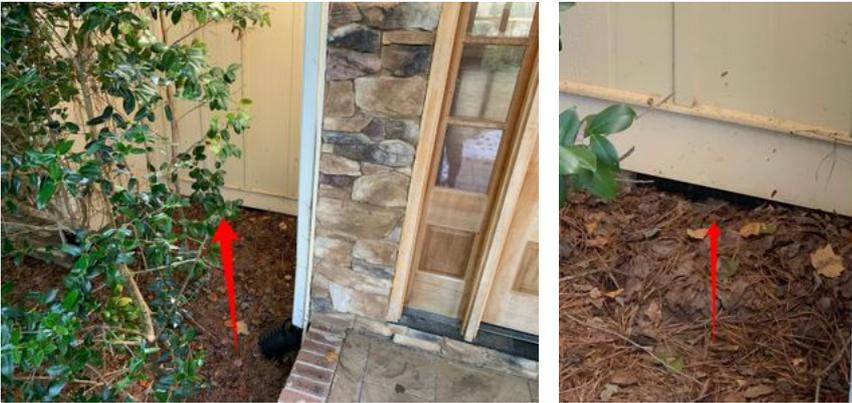
The foundation vents at multiple locations are below the exterior grade. This allows water to enter the crawlspace and prevents proper ventilation. Installing foundation vent wells and properly grading is recommended.

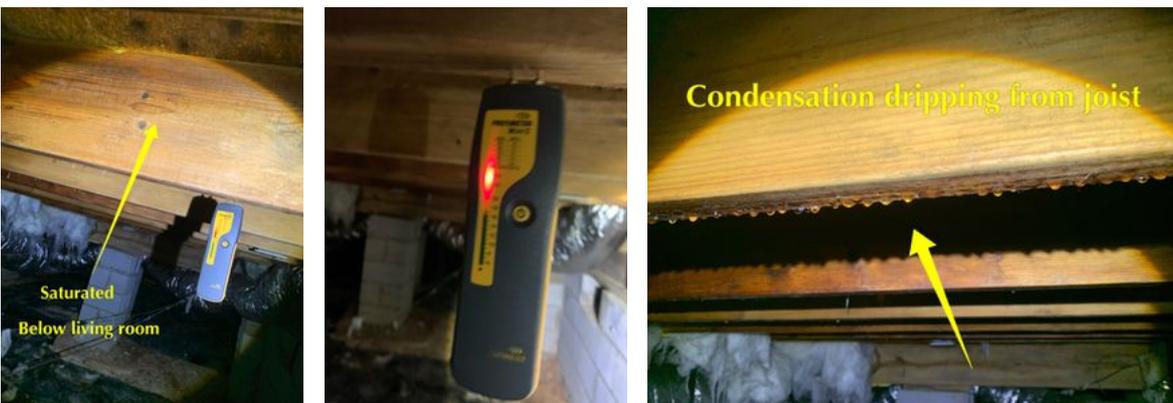
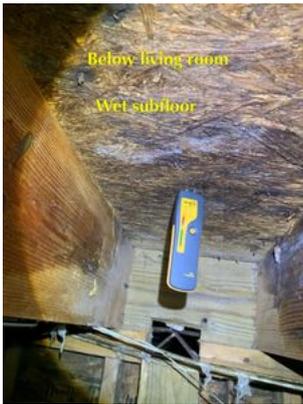
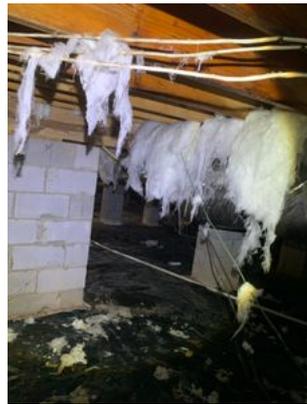
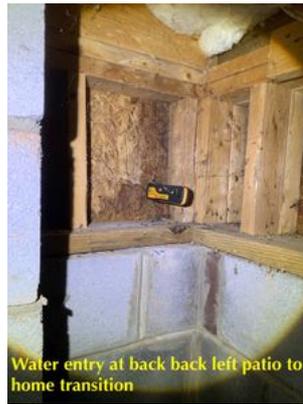
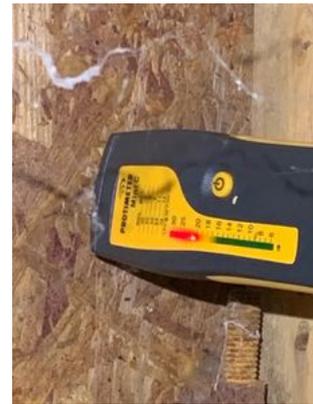
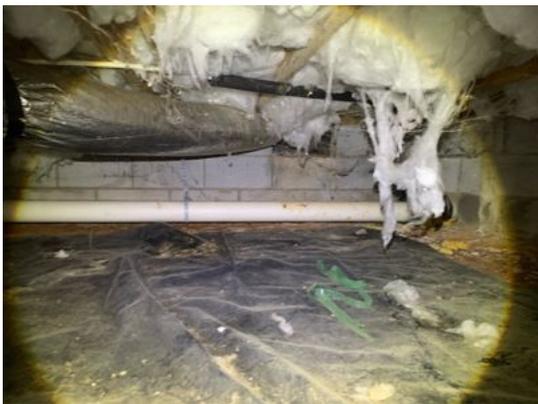
A qualified contractor is recommended to evaluate multiple areas of active water entry into the crawlspace, elevated moisture levels on the floor, structure, wet/damaged/missing insulation. An invasive evaluation is recommended to determine the extent of any moisture damage.
