Home Inspection Report

Builder's Warranty Inspection

123 ABC St.

Inspected on Mon, Jul 15 2019 at 10:05 AM

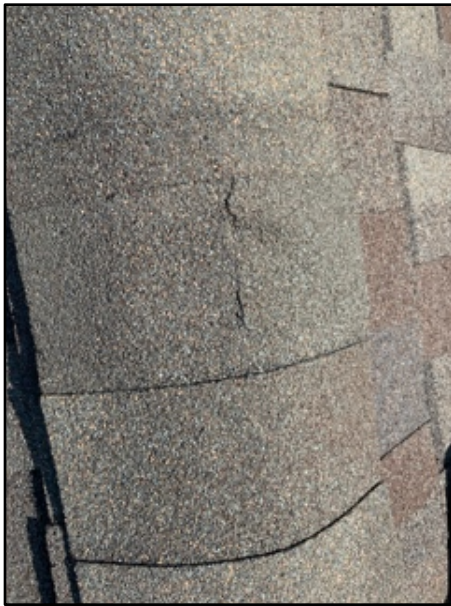
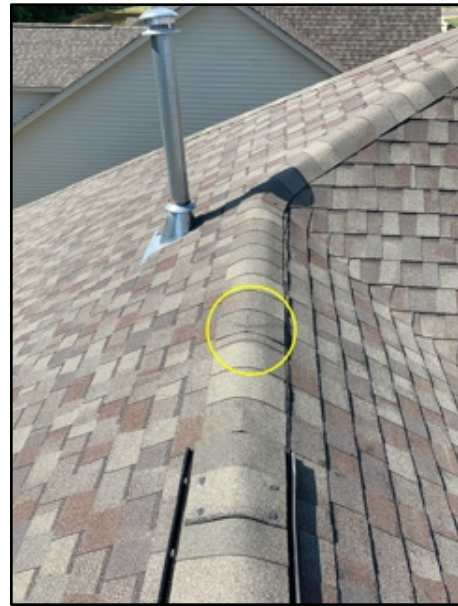
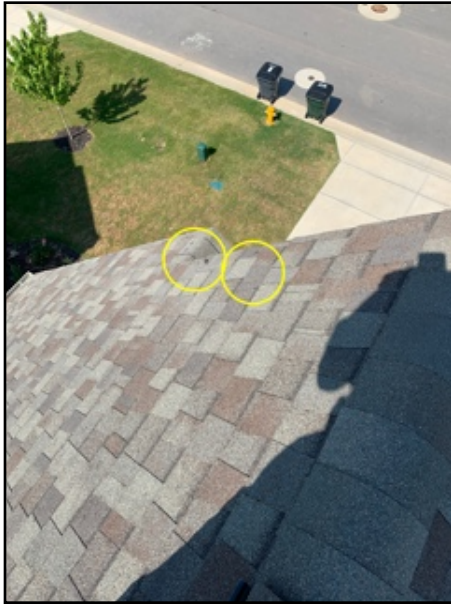
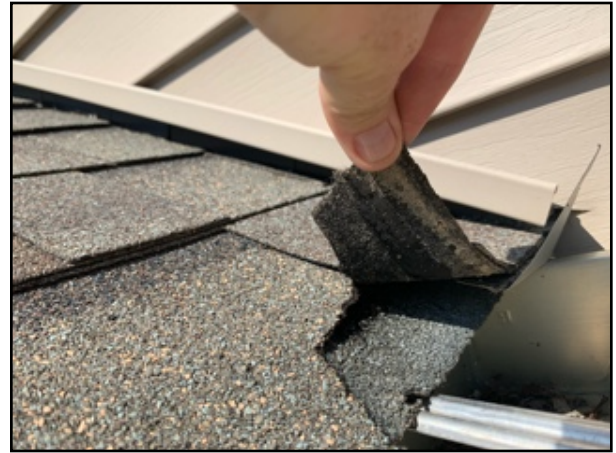
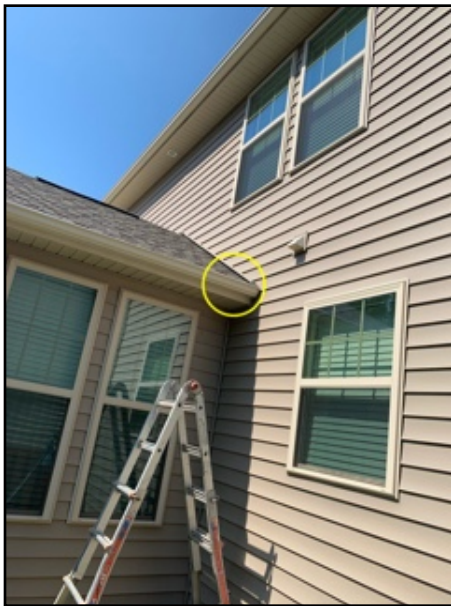
- 1) In multiple locations, roof shingles are torn or have nail pops. This could lead to water intrusion. Replace/seal any and all damaged shingles and seal any exposed nail heads.
- 2) There are multiple roofing nails scattered on the roof covering in different locations. Over time, these nails will cause indentations and possible penetrations through the shingles and could develop water intrusion issues. Remove all loose fasteners to prevent damage.

In multiple locations, roof shingles are torn or have nail pops. This could lead to water intrusion. Replace/seal any and all damaged shingles and seal any exposed nail heads.

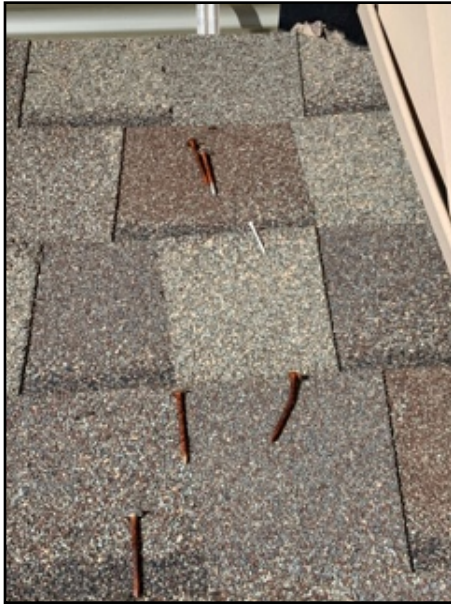
Figure 3-1

There a multiple roofing nails scattered on the roof covering in different locations. Over time, these nails will cause indentations and possible penetrations through the shingles and could develop water intrusion issues. Remove all loose fasteners to prevent damage.

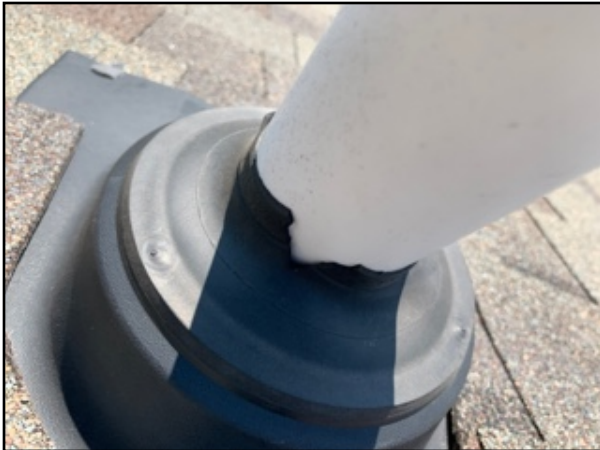
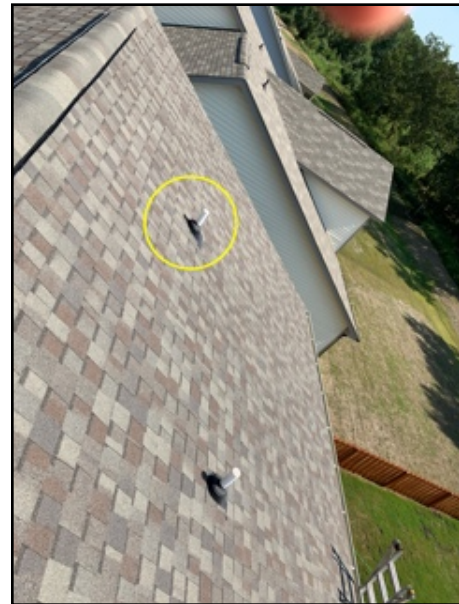
- 3) The neoprene vent stack boot on the back slope is torn which will allow water to penetrate the roof surface and could deteriorate structural components. Replacing the neoprene boot is required by licensed contractor.
- 4) The roofing sealant around the rain collar of the furnace vent is loose and does not seal the collar properly. This will allow water to enter into the structure and possibly damage around and components. Re-seal the rain collar to prevent water intrusion.

The neoprene vent stack boot on the back slope is torn which will allow water to penetrate the roof surface and could deteriorate structural components. Replacing the neoprene boot is required by licensed contractor.

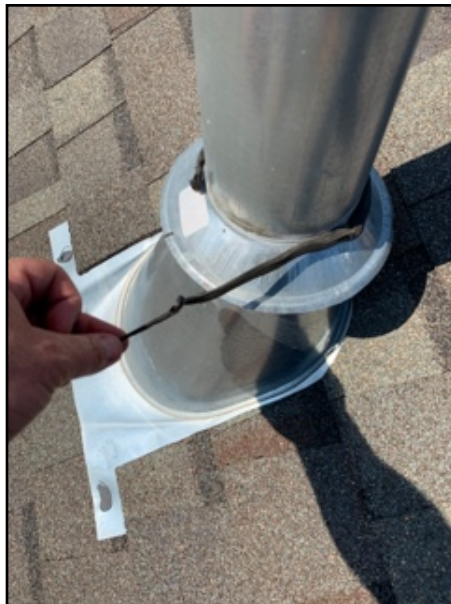
Figure 5-1

The roofing sealant around the rain collar of the furnace vent is loose and does not seal the collar properly. This will allow water to enter into the structure and possibly damage around and components. Re-seal the rain collar to prevent water intrusion.

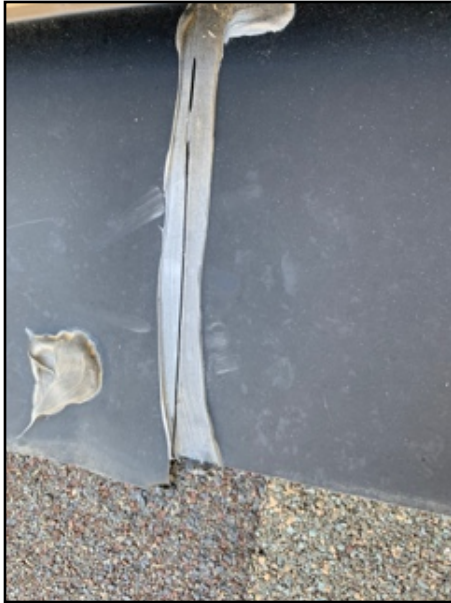
Figure 6-1

- 5) Reseal the front porch roof headwall flashing prevent water entry.
- 6) The kick out flashing on the back roof is installed improperly. The flashing should have an angle of approximately 110° in order to divert water away from the cladding and into the gutter. Repair/replace the flashing as needed for proper function.

Reseal the front porch roof headwall flashing prevent water entry.

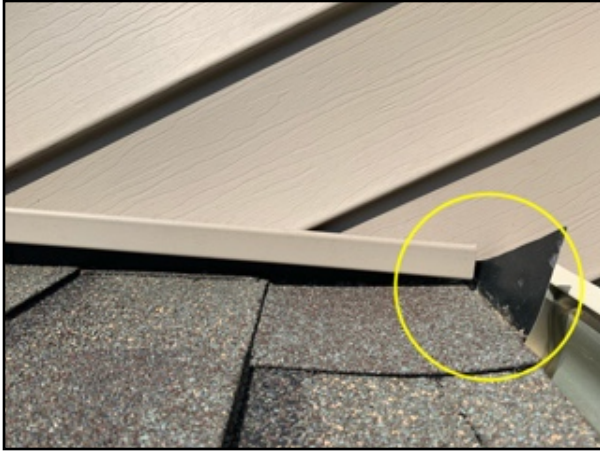
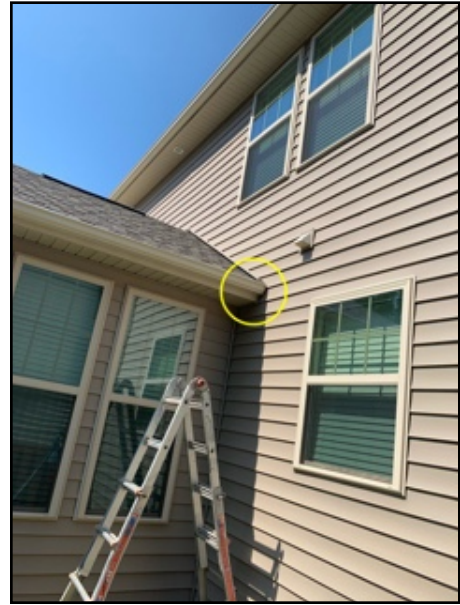
The kick out flashing on the back roof is installed improperly. The flashing should have an angle of approximately 110° in order to divert water away from the cladding and into the gutter. Repair/replace the flashing as needed for proper function.

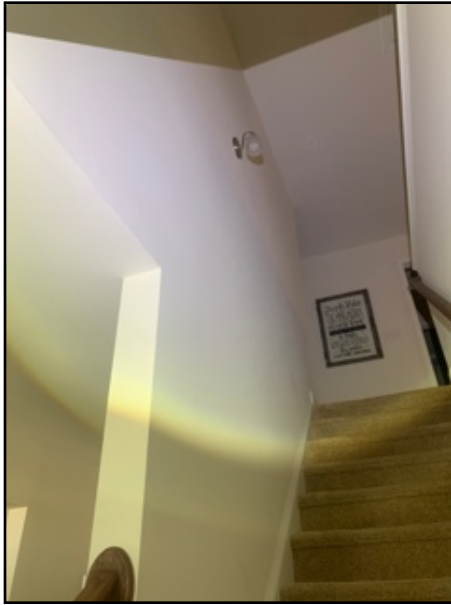
Figure 11-1

- 7) The 3-way switch to the stair light is not wired properly. It will not function in any position on both the downstairs and upstairs switch. Evaluation and repair by a licensed electrician is required.

The 3-way switch to the stair light is not wired properly. It will not function in any position on both the downstairs and upstairs switch. Evaluation and repair by a licensed electrician is required.

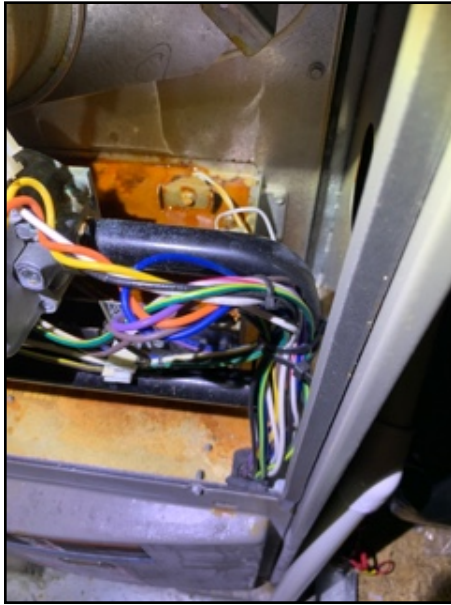
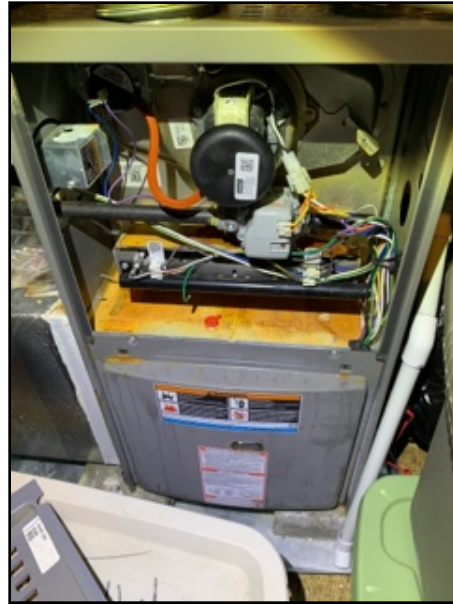
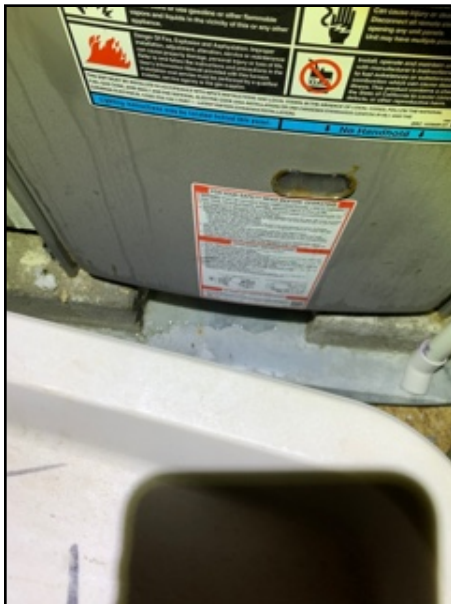
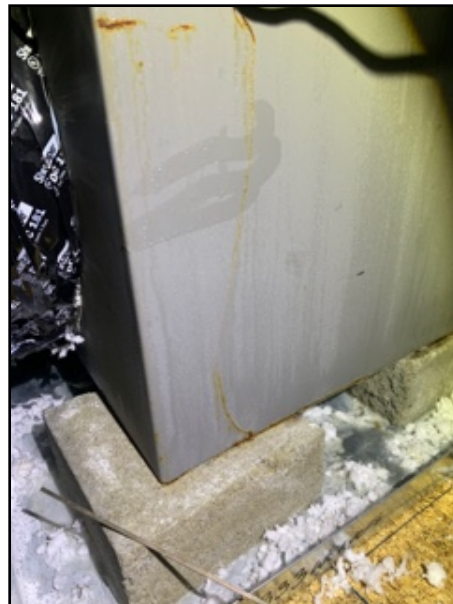
8) There is excessive rust inside the attic air handler for a 1 yr old unit. There is water in the emergency overflow pan. Further evaluation and repair by a licensed HVAC technician is required.

There is excessive rust inside the attic air handler for a 1 yr old unit. There is water in the emergency overflow pan. Further evaluation and repair by a licensed HVAC technician is required.

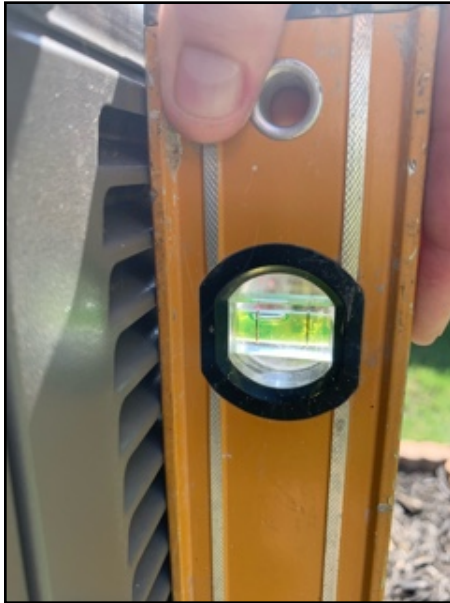
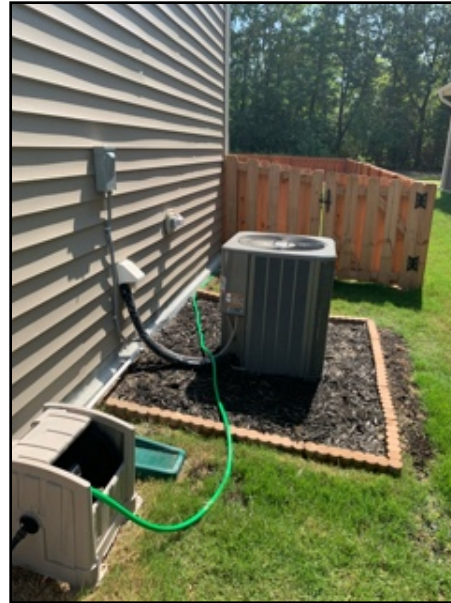
9) The exterior HVAC condenser is not installed level/plumb. All condensers should be installed level and plumb to ensure proper function. Adjust the condenser pad as needed for this repair.

The exterior HVAC condenser is not installed level/plumb. All condensers should be installed level and plumb to ensure proper function. Adjust the condenser pad as needed for this repair.

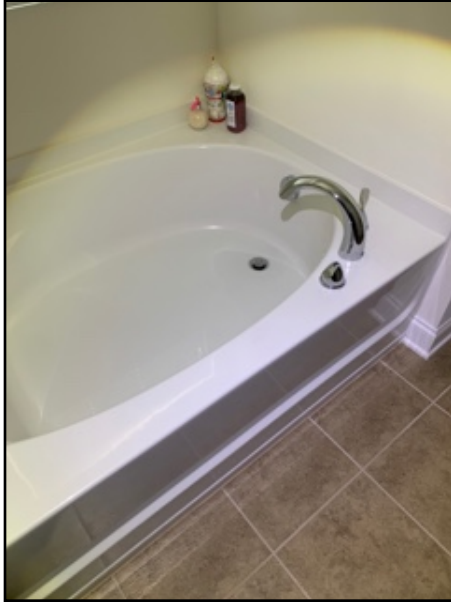
Figure 16-1

10) The master tub drains very slowly. Clean or repair as needed for proper function.

The master tub drains very slowly. Clean or repair as needed for proper function.

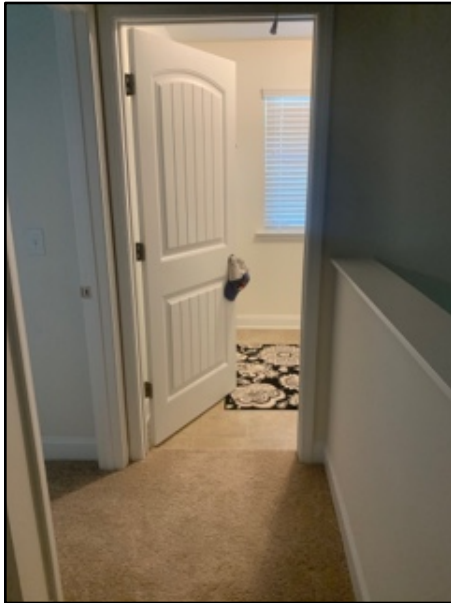
Figure 19-1

11) The laundry room door does not latch properly to the strike plate, which will not allow the door to lock properly. Adjust the door as needed for repair.

The laundry room door does not latch properly to the strike plate, which will not allow the door to lock properly. Adjust the door as needed for repair.

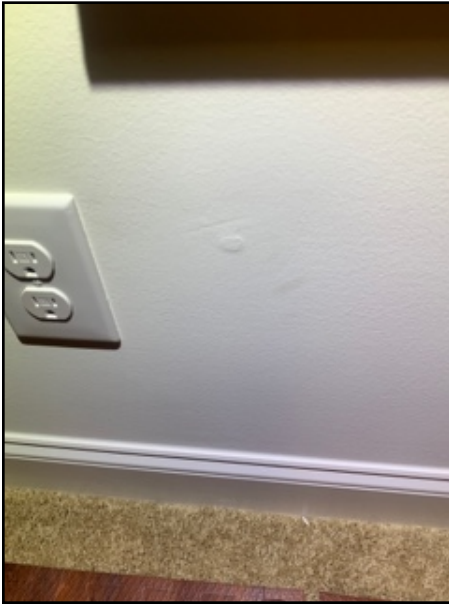
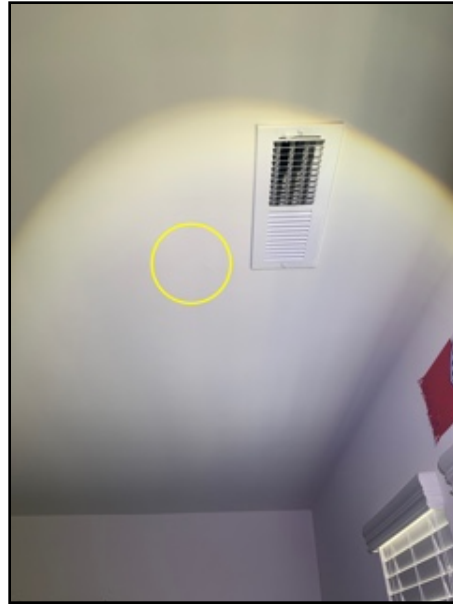
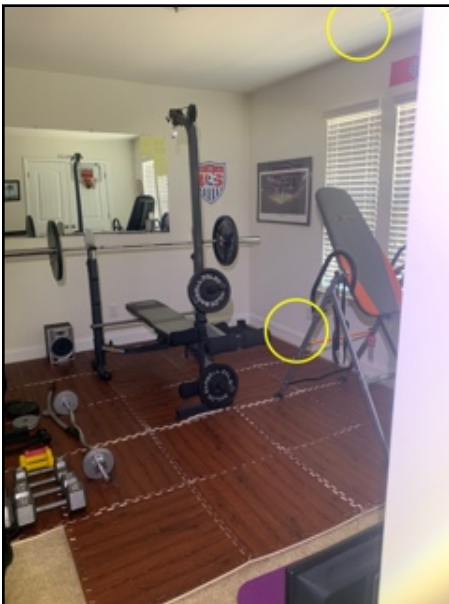
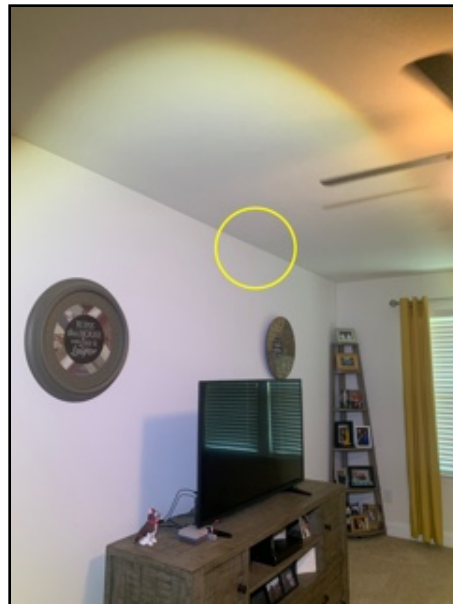
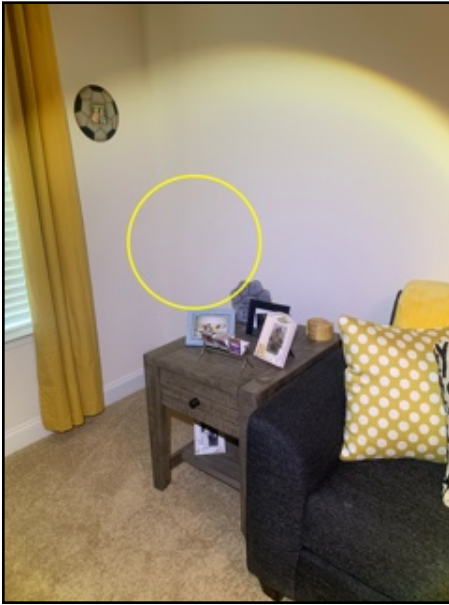
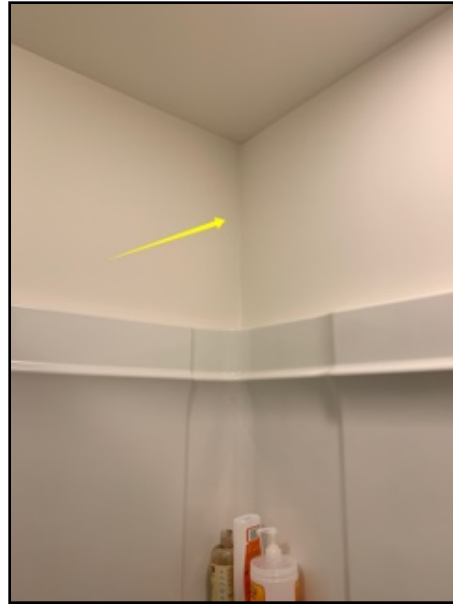
12) The ceiling/walls in several rooms are showing the beginning signs of nail pops corner bead and tape joint cracks, which over time could increase in size and/or become exposed. (cosmetic)

The ceiling/walls in several rooms are showing the beginning signs of nail pops corner bead and tape joint cracks, which over time could increase in size and/or become exposed. (cosmetic)

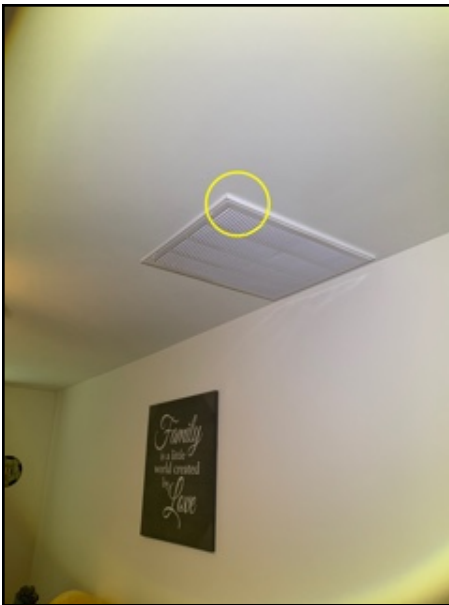
Figure 21-1

13) The ceiling in the upstairs living room shows possible active water stains. Further evaluation and repair by a licensed contractor is recommended.

The ceiling in the upstairs living room shows possible active water stains. Further evaluation and repair by a licensed contractor is recommended.
