Pait Home Inspections of North Carolina, LLC

Home Inspection Report

Sample Builder's Warranty

Inspected on Sat, Apr 20 2019 at 9:02 AM

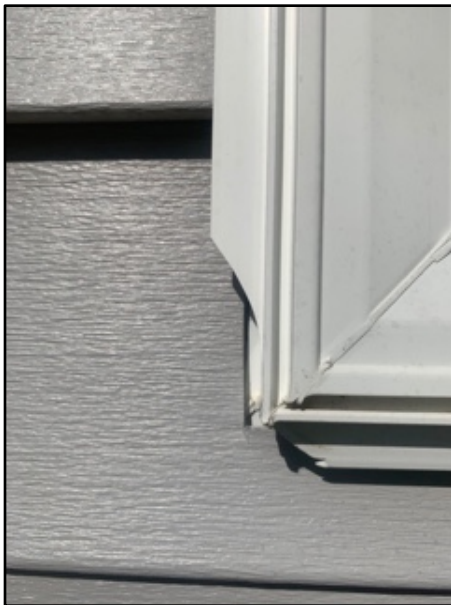
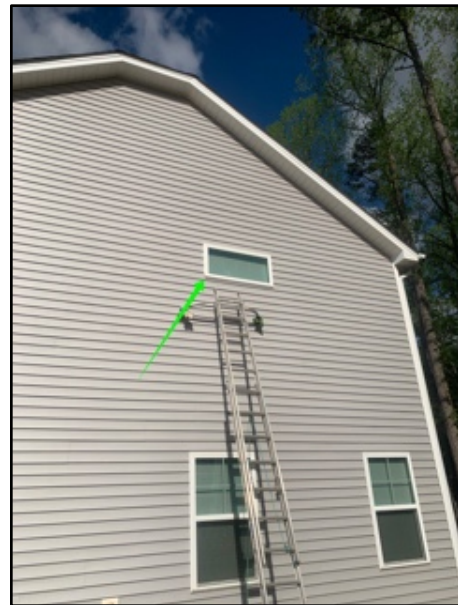
Comment 2:

1) The second-floor picture window on the right exterior of the home has a broken channel fin which helps in keeping water from entering behind the vinyl. Repairing or replacing this fin/window is recommended to keep water from entering and possibly causing damage to surrounding components.

Windows: Vinyl, Double pane-Insulated glass
Condition: Minor Defect

The second-floor picture window on the right exterior of the home has a broken channel fin which helps in keeping water from entering behind the vinyl. Repairing or replacing this fin/window is recommended to keep water from entering and possibly causing damage to surrounding components.

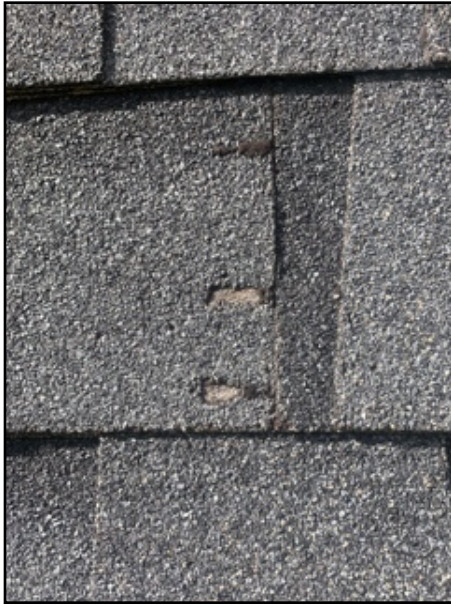
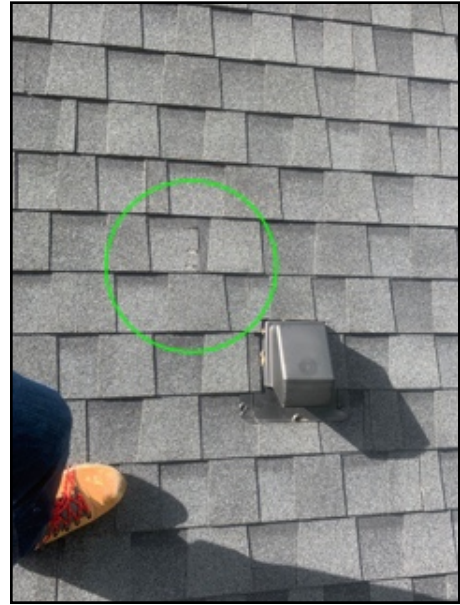
Comment 4:

3) There is at least one roof shingle that has been damaged either during installation or during the manufacturing process. There are no granules covering the fiberglass mesh which overtime will deteriorate with sunlight and lead to possible water intrusion. Replace any and all damaged shingles.

There is at least one roof shingle that has been damaged either during installation or during the manufacturing process. There are no granules covering the fiberglass mesh which overtime will deteriorate with sunlight and lead to possible water intrusion. Replace any and all damaged shingles.

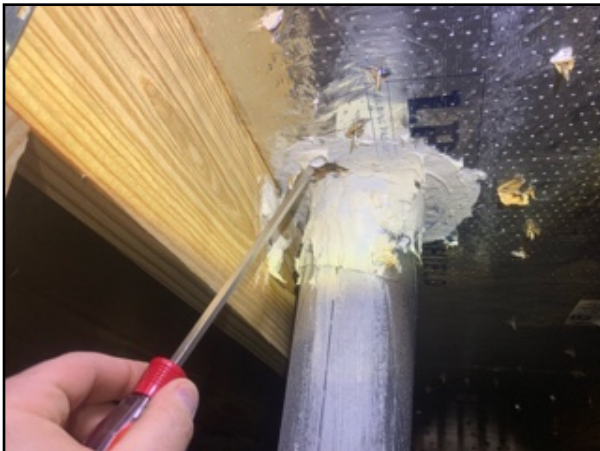
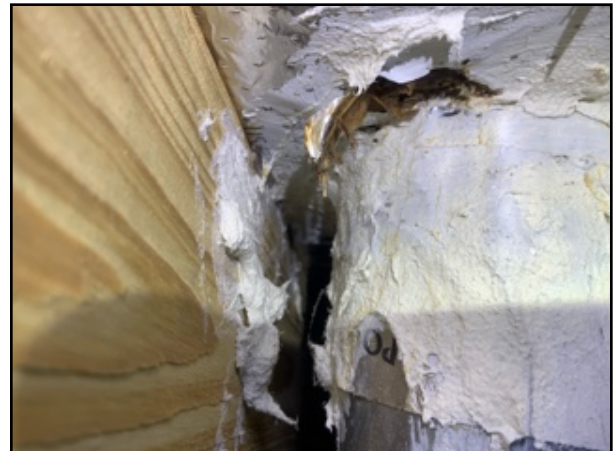
Comment 5:

4) The roof shows signs of previous or current water leaking at the dryer vent penetration. Water damage to the roof decking and water staining is noticeable on the dryer vent ductwork. Repair by a licensed roofing contractor is recommended.

The roof shows signs of previous or current water leaking at the dryer vent penetration. Water damage to the roof decking and water staining is noticeable on the dryer vent ductwork. Repair by a licensed roofing contractor is recommended.

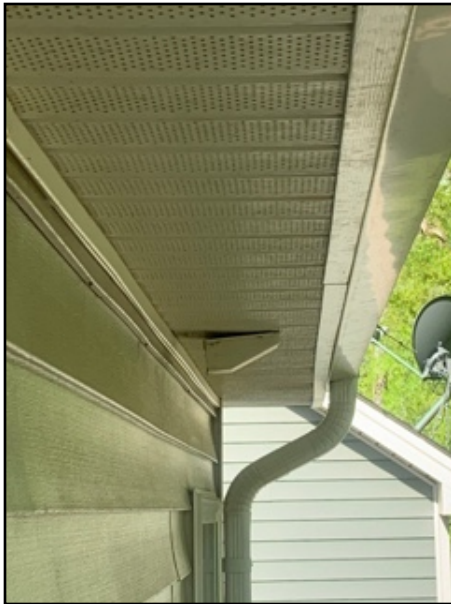
Comment 6:

5) The exhaust fan vents on the rear soffit have become loose/ detached. They have only been fastened with a roofing nail. Over time, this will worsen and possibly completely fall off. Reattaching with an exterior grade screw is recommended.

The exhaust fan vents on the rear soffit have become loose/ detached. They have only been fastened with a roofing nail. Over time, this will worsen and possibly completely fall off. Reattaching with an exterior grade screw is recommended.

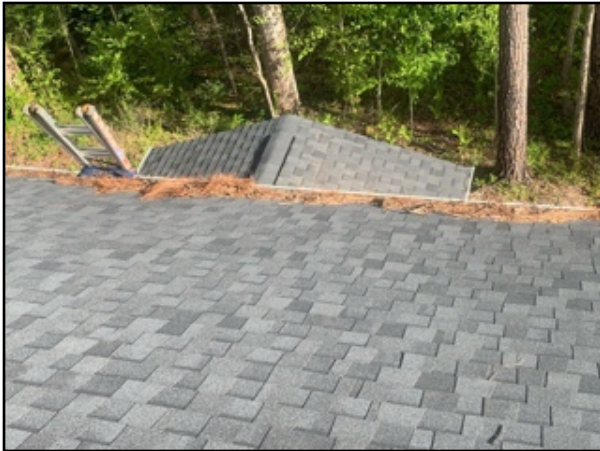
Comment 7:

6) The gutters, in multiple locations, are filled with debris which will prevent water from exiting into the downspouts. This could cause water runoff in areas that could present problems. Cleaning out the gutters and ensuring functional flow out of the downspouts is recommended.

The gutters, in multiple locations, are filled with debris which will prevent water from exiting into the downspouts. This could cause water runoff in areas that could present problems. Cleaning out the gutters and ensuring functional flow out of the downspouts is recommended.

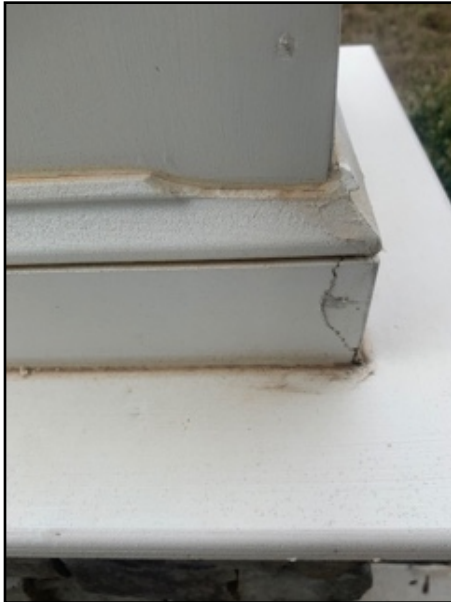
8) The front porch column base trim is cracked or broken. The composite base is already beginning to dry rot due to not being sealed or painted. Recommend repairing and painting to prevent further dry rot or damage.

Comment 10:
The front porch column base trim is cracked or broken. The composite base is already beginning to dry rot due to not being sealed or painted. Recommend repairing and painting to prevent further dry rot or damage.

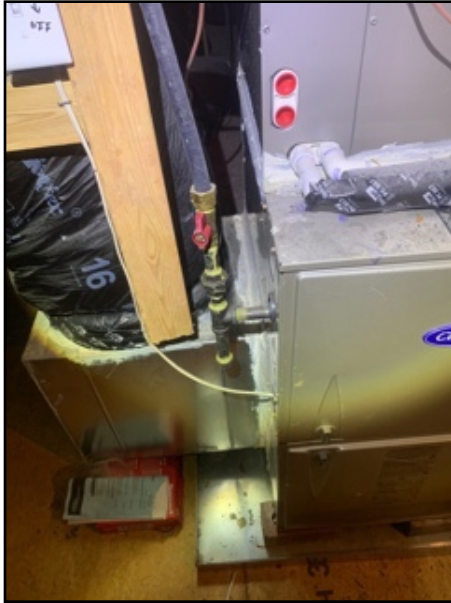
Comment 15:
Gas shutoff for the attic furnace.

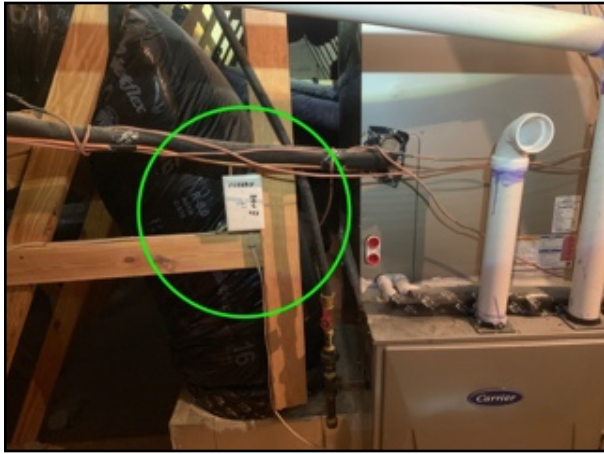
Comment 16:
Furnace emergency shutoff switch in the attic.

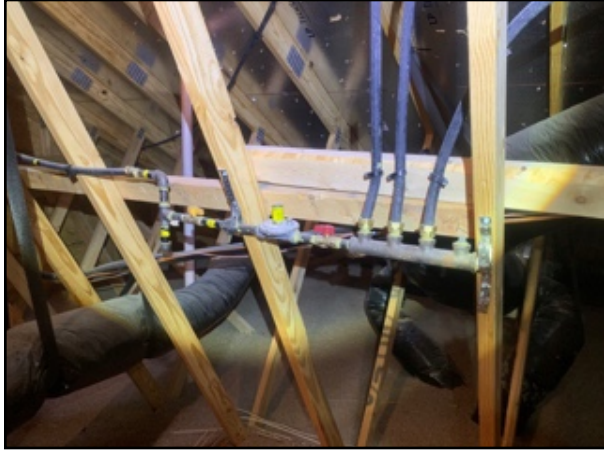
Comment 19:
Gas manifold in the attic.

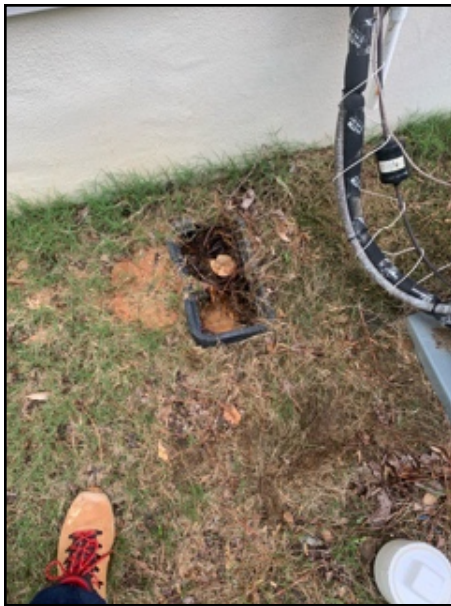
9) On the left exterior of the house, there is a control valve box that is missing a lid and is full of mud and debris. This will not allow ease of shut off during an emergency situation. Installing a valve box lid and cleaning out the existing debris is recommended.

Comment 20:
On the left exterior of the house, there is a control valve box that is missing a lid and is full of mud and debris. This will not allow ease of shut off during an emergency situation. Installing a valve box lid and cleaning out the existing debris is recommended.

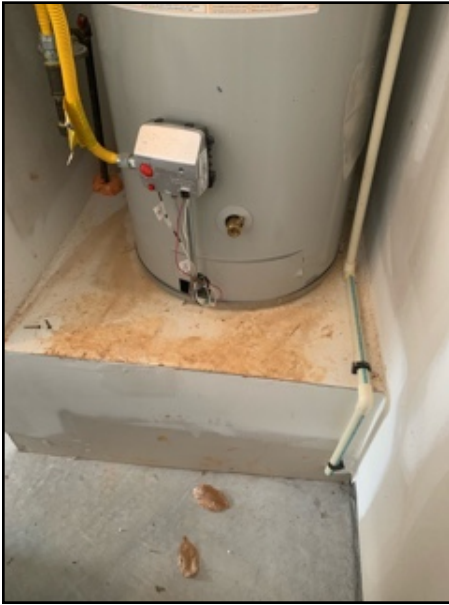
11) The water heater located in the garage does not have a emergency overflow pan installed. Current guidelines require pans to be installed anywhere damage could occur from a water leak. Installing an overflow pan with drainage the exterior is recommended to avoid potential damage to wall framing, sheet rock, or any surrounding interior components.

Comment 23:
The water heater located in the garage does not have a emergency overflow pan installed. Current guidelines require pans to be installed anywhere damage could occur from a water leak. Installing an overflow pan with drainage the exterior is recommended to avoid potential damage to wall framing, sheet rock, or any surrounding interior components.

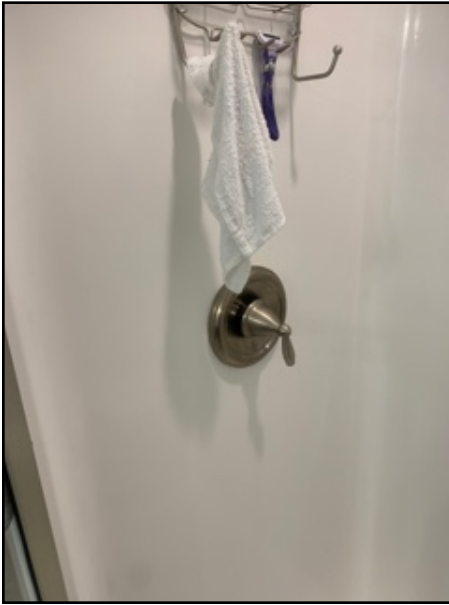
Comment 24:

12) The master Bathroom shower valve handle is loose and should be tightened to avoid completely coming off.

The master Bathroom shower valve handle is loose and should be tightened to avoid completely coming off.

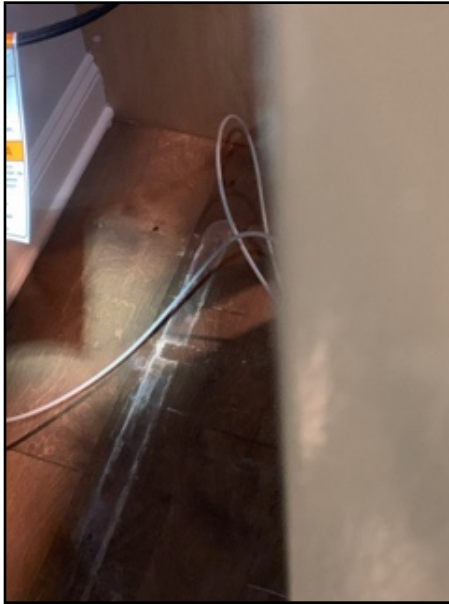
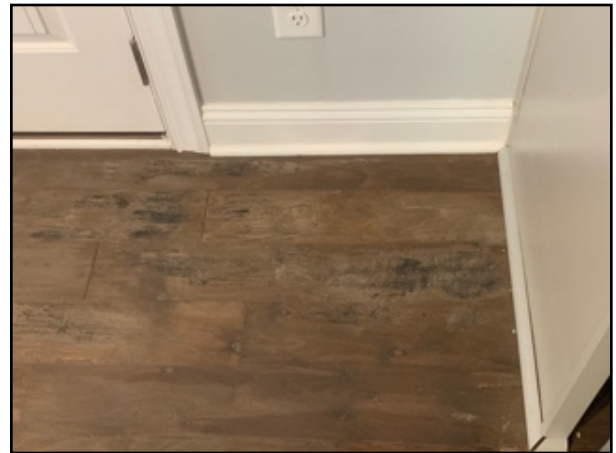
Comment 25:

13) There is a leak from the refrigerator that has caused damage to the wood flooring, as well as the cabinet end panel. The wood flooring is showing signs of organic growth that could present an air quality issue. Repairing the leak and replacing the affected areas of the floor and cabinet is recommended.

Refrigerator:
Condition: Major Defect

There is a leak from the refrigerator that has caused damage to the wood flooring, as well as the cabinet end panel. The wood flooring is showing signs of organic growth that could present an air quality issue. Repairing the leak and replacing the affected areas of the floor and cabinet is recommended.

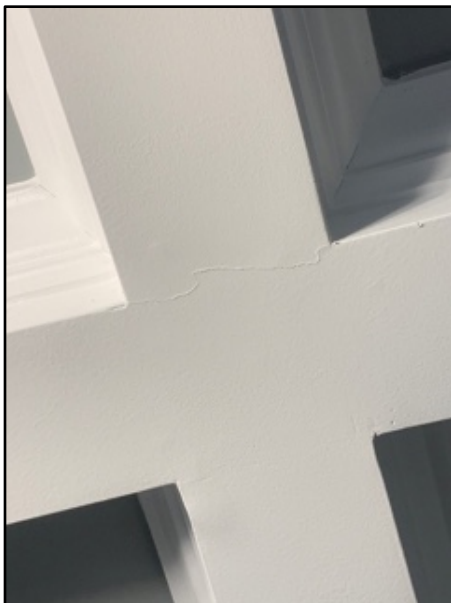
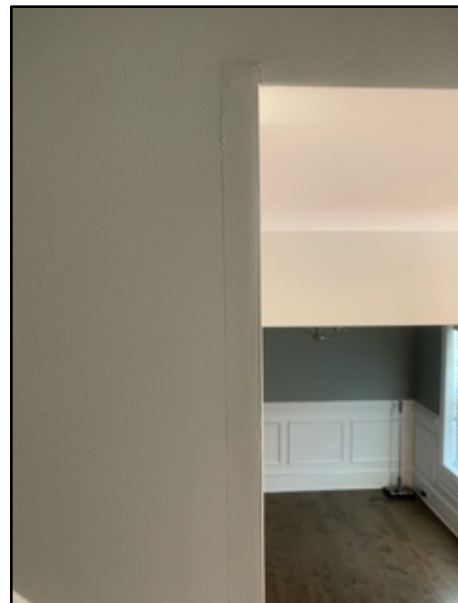
Comment 28:

14) The ceiling/walls in several rooms, including but not limited to the dining room, stairwell and entry hallway, are showing the beginning signs of nail pops and tape joint cracks, which over time will increase in size and/or become exposed. (cosmetic)

The ceiling/walls in several rooms, including but not limited to the dining room, stairwell and entry hallway, are showing the beginning signs of nail pops and tape joint cracks, which over time will increase in size and/or become exposed. (cosmetic)

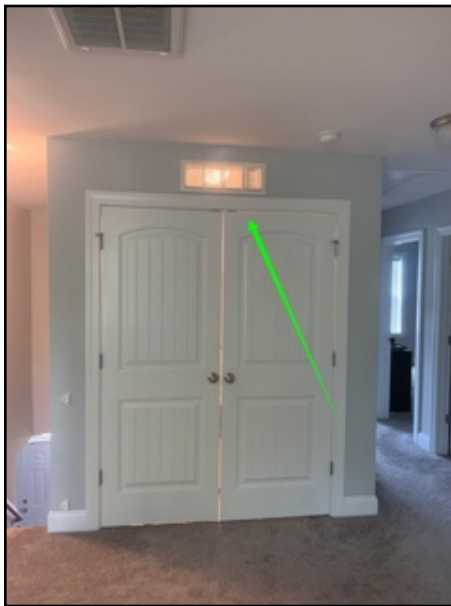
Comment 30:

15) The ball latch to the right laundry door on the second floor does not latch properly. Adjust or replace the ball catch as needed.

The ball latch to the right laundry door on the second floor does not latch properly. Adjust or replace the ball catch as needed.
