Pait Home Inspections of North Carolina, LLC

Home Inspection Report

Wendell, NC 27591

Inspected on Sat, Apr 20 2019 at 1:25 PM

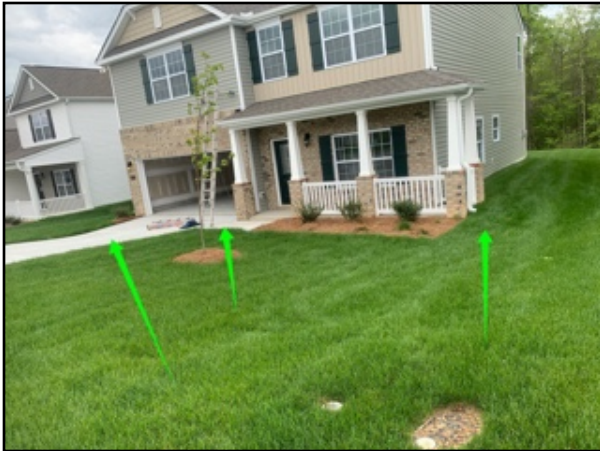
Figure 2-1

In the front of the house, the grading slopes back toward the structure. While there was no standing water at the time of inspection, this is an area to monitor for standing water during rainstorms. Additional drainage measures may be required.

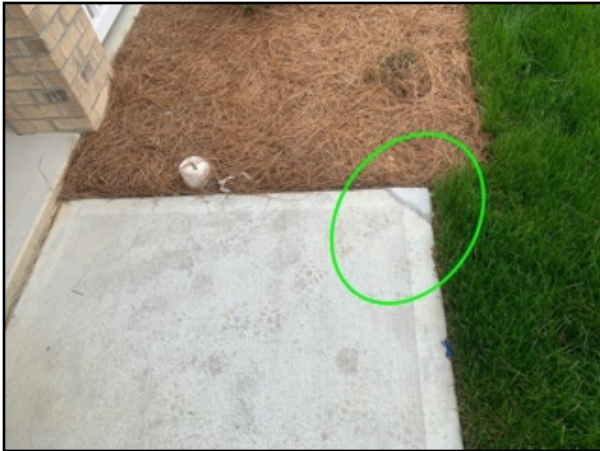
Figure 3-1

Comment 3:
Item of note. Previous concrete repair to the front walkway.

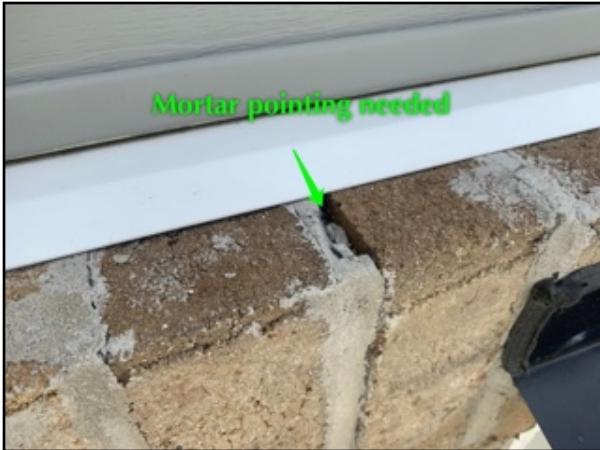
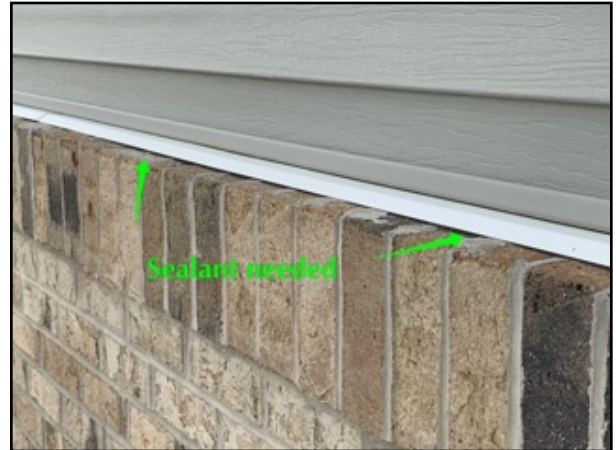
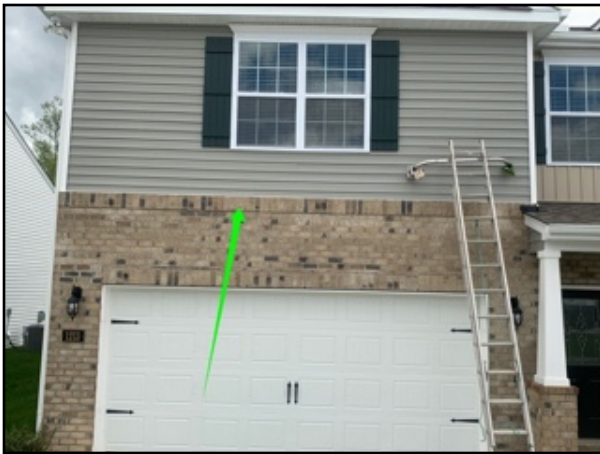
1) The flashing above the brick on the garage needs to be sealed to prevent water from running back toward the structure of the home. In addition one or more mortar joints need to be repointed to ensure a proper seal to prevent water intrusion.

Comment 4:
The flashing above the brick on the garage needs to be sealed to prevent water from running back toward the structure of the home. In addition one or more mortar joints need to be repointed to ensure a proper seal to prevent water intrusion.

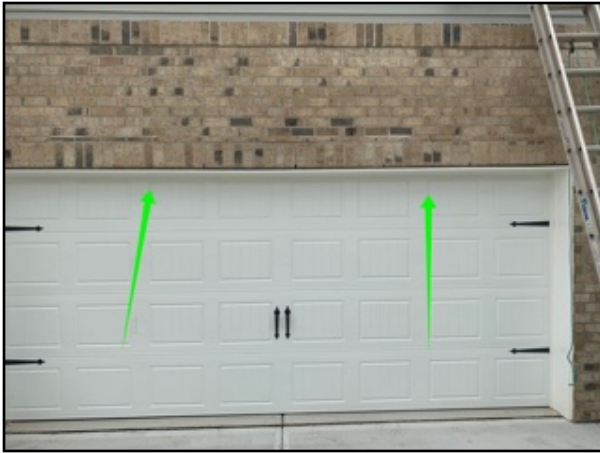
Figure 5-1

2) The garage exterior header trim board needs additional fasteners installed to prevent sagging overtime, which could lead to water intrusion.

The garage exterior header trim board needs additional fasteners installed to prevent sagging overtime, which could lead to water intrusion.

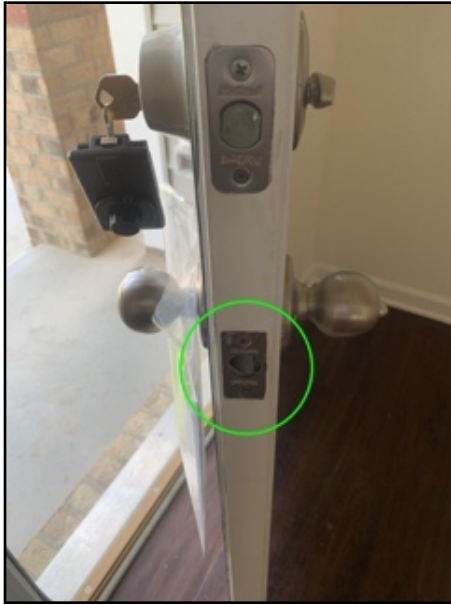
Figure 7-1

3) The front exterior door deadbolt and/or door knob does not latch properly. Repair/replace as necessary.

The front exterior door deadbolt and/or door knob does not latch properly. Repair/replace as necessary.

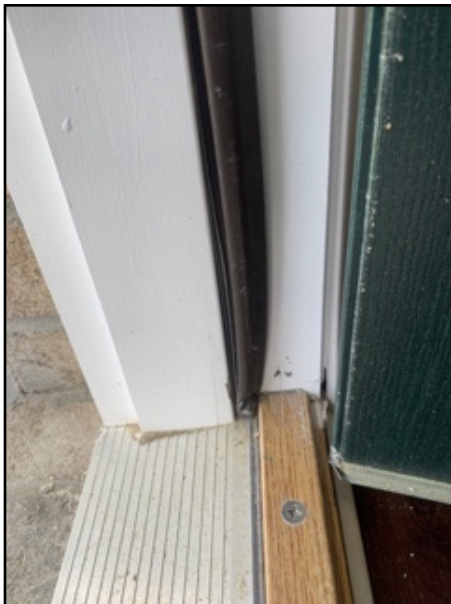
Figure 8-1

4) The front door weatherstripping has become detached from the channel which makes it difficult for the front door to shut/ latch properly and over time will result in damage to the weatherstripping. Repair or replace the weatherstripping as needed.

The front door weatherstripping has become detached from the channel which makes it difficult for the front door to shut/ latch properly and over time will result in damage to the weatherstripping. Repair or replace the weatherstripping as needed.

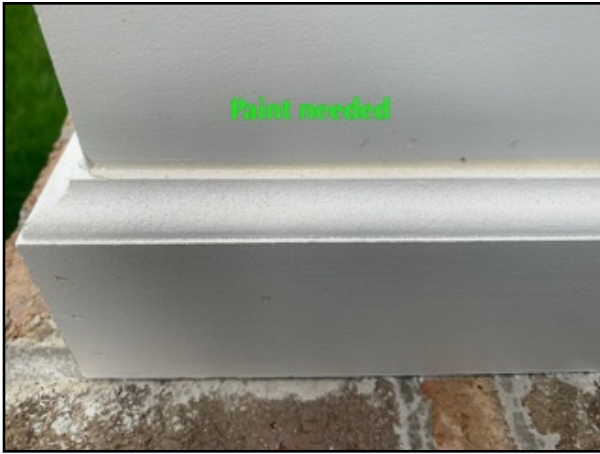
Figure 9-1

5) Adding another coat of paint to the front porch columns is recommended to seal the composite material and prevent premature dry rot.

Adding another coat of paint to the front porch columns is recommended to seal the composite material and prevent premature dry rot.

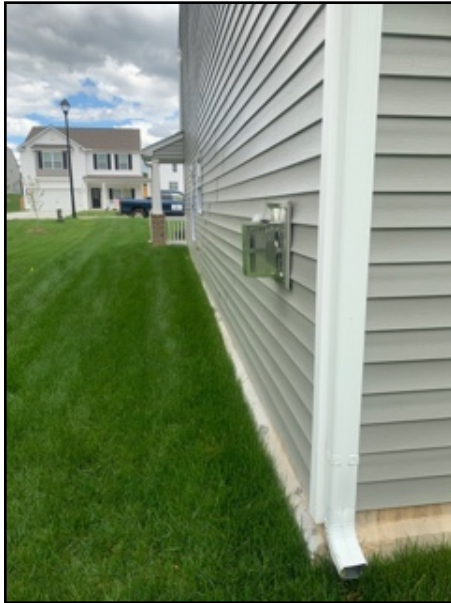
Figure 11-1

The fireplace exhaust vent is very low to grade level which presents a safety issue if accidentally touched when it is hot. Be mindful of this danger when the fireplace is turned on.

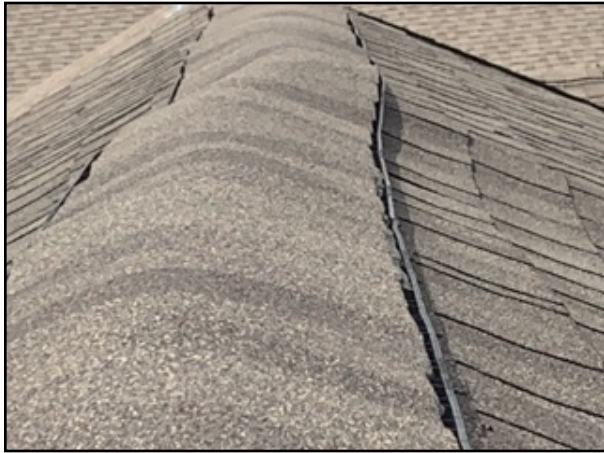
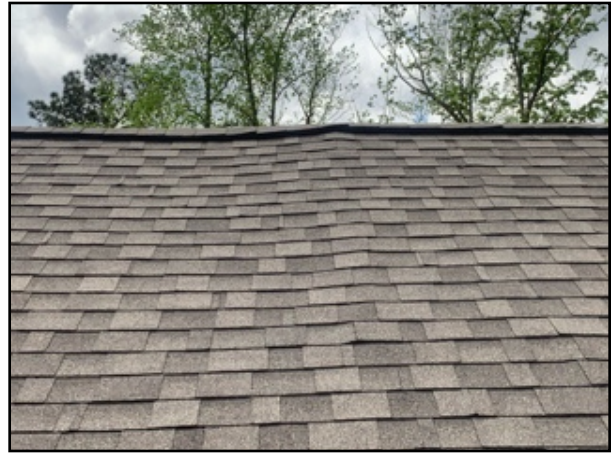
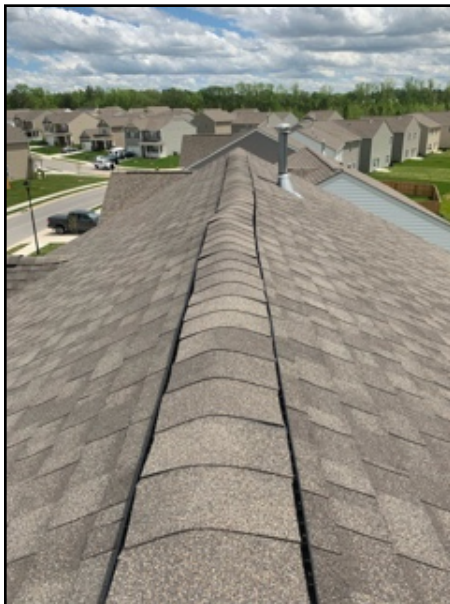
7) At the peak of the roof, the truss framing appears to be installed out of line. In two locations, the roof framing sticks out significantly beyond other sections of the roof. Further evaluation by a licensed contractor is recommended.

Comment 14:
At the peak of the roof, the truss framing appears to be installed out of line. In two locations, the roof framing sticks out significantly beyond other sections of the roof. Further evaluation by a licensed contractor is recommended.

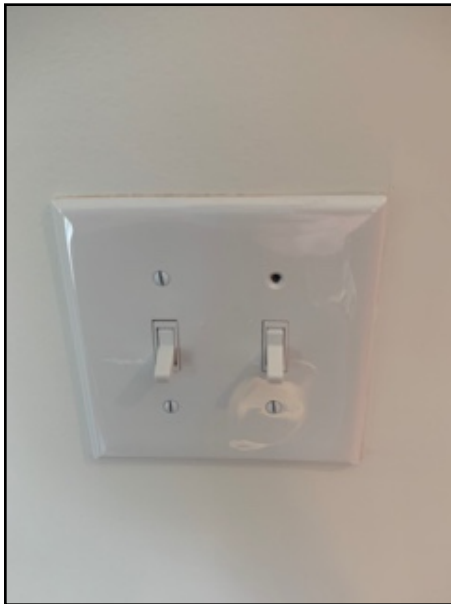
Figure 18-1

8) Missing switch plate screw at back door.

Comment 18:
Missing switch plate screw at back door.

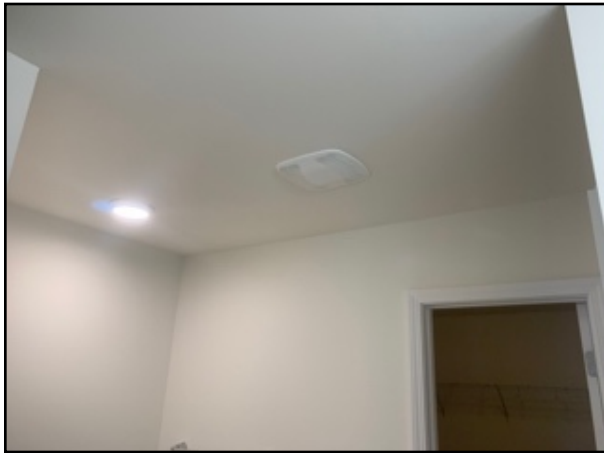
Figure 23-1

9) The master bathroom exhaust fan does power up when switch on by the light switch. Repair or replace as needed.

The master bathroom exhaust fan does power up when switch on by the light switch. Repair or replace as needed.

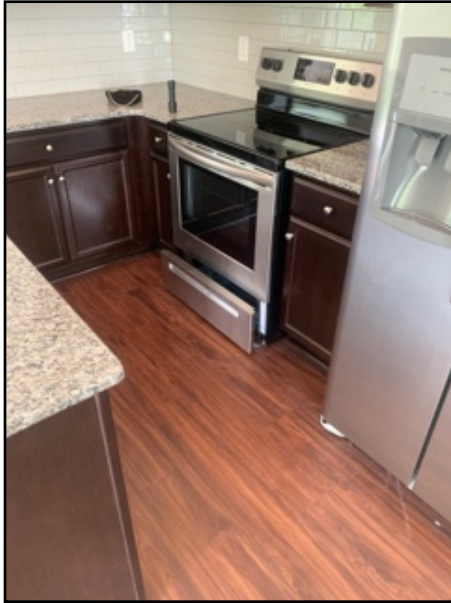
Figure 24-1

10) The bottom storage door of the slide in range will not open or close.

The bottom storage door of the slide in range will not open or close.

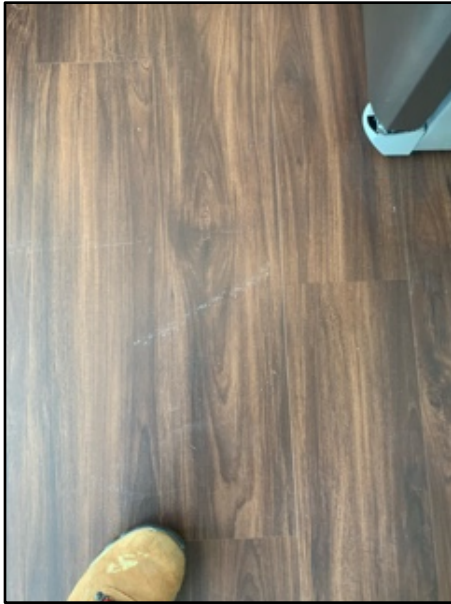
Figure 28-1

Comment 28:
Minor cosmetic scratches to the kitchen floor.

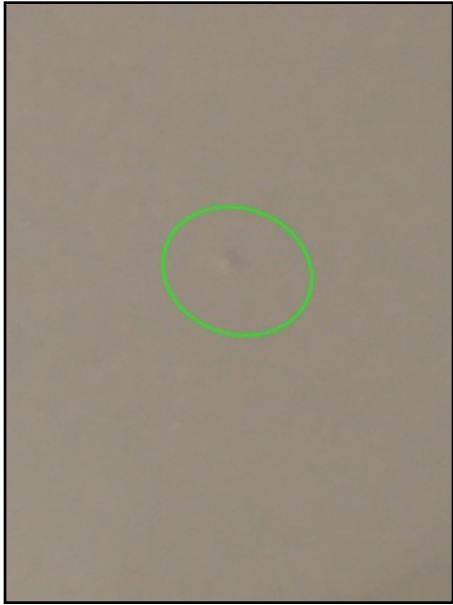
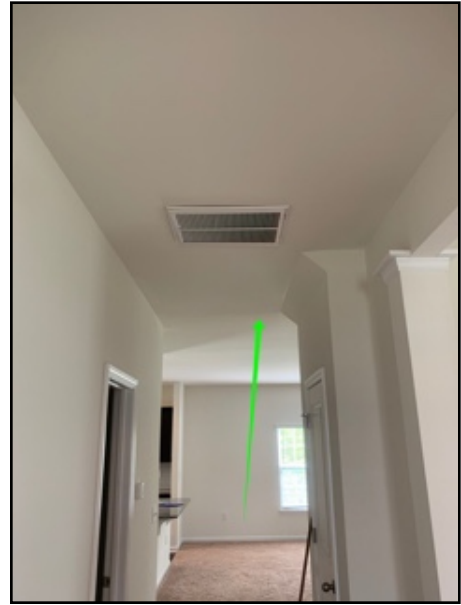
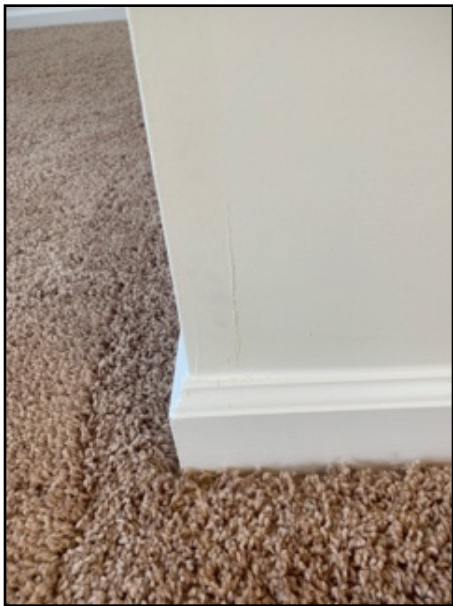
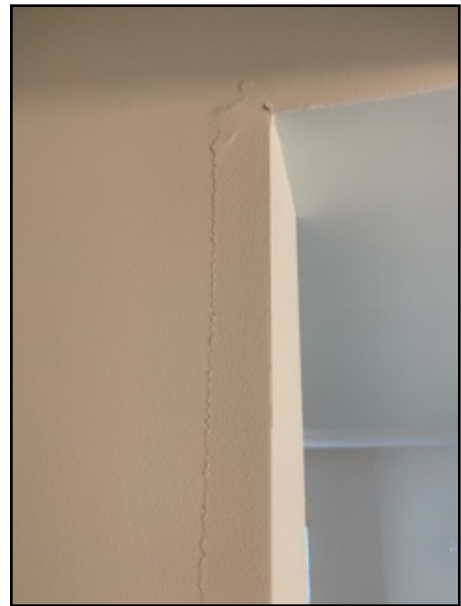
Comment 29:
The ceiling and/or in several rooms, including but not limited to the entry hallway at the stairwell wall is showing the beginning signs of nail pops, corner bead cracks, which in time will become exposed or more extensive. (cosmetic)

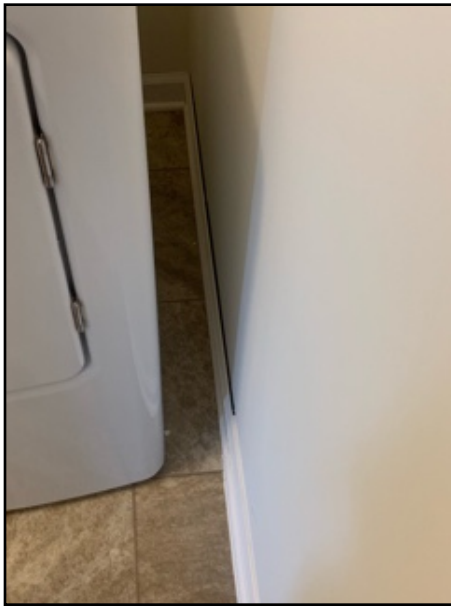
Figure 30-1

There is caulking missing to the laundry room base trim. ***Cosmetic issue

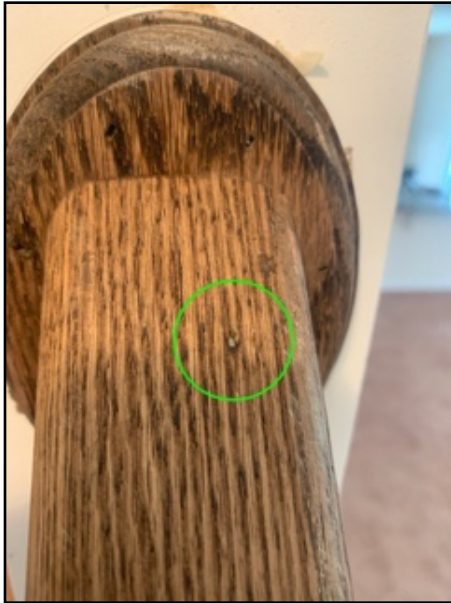
Figure 34-1

12) A finish nail is protruding through the stair handrail at the stair rail cap. This could lead to an accidental cut or other injury. Ensure sure all fasteners are fully driven.

A finish nail is protruding through the stair handrail at the stair rail cap. This could lead to an accidental cut or other injury. Ensure sure all fasteners are fully driven.

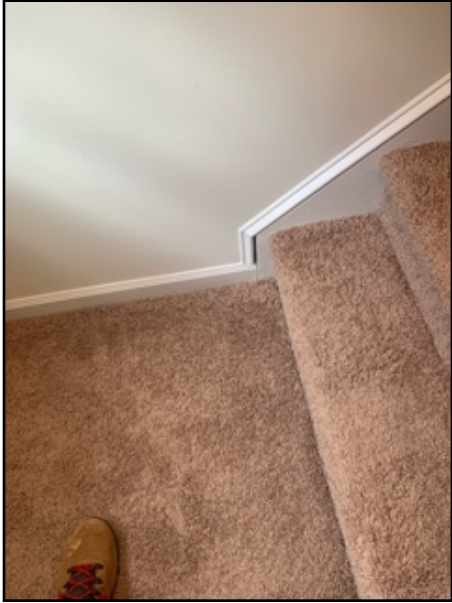
Figure 35-1

Caulking is missing and there are minor damaged areas to the stair skirt trim.

***Cosmetic issue
