## Home Inspection Report

123 Sample Buyer's Report  
Youngsville, NC 27587

Inspected By: Stephen Pait, CMI- Lic # 4329 &  
Septic Lic #72451

Inspected On Mon, Sep 25, 2023 at 1:00 PM

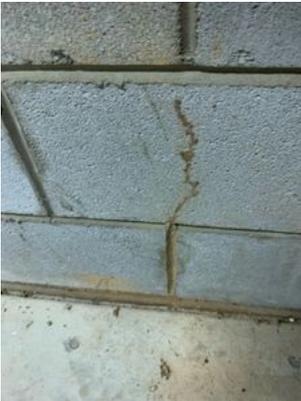
Signs of termites were visible in the garage. Contact a licensed pest company for treatment if the current owners cannot provide proof of previous treatment.

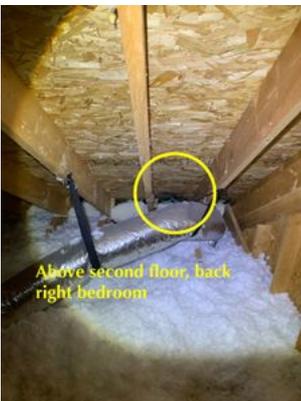
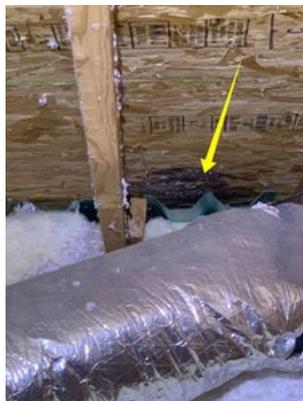
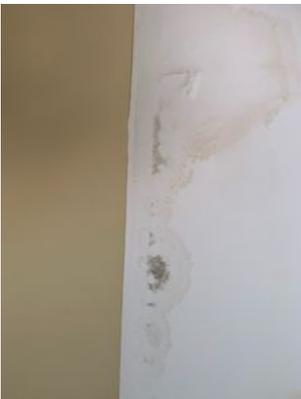
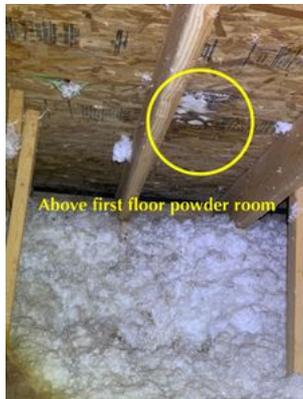
**Comment 19**

A license roofing contractor is recommended to perform a full evaluation of the roof, covering due to active leaks and multiple moisture stained areas of the ceiling observed at the time of the inspection.

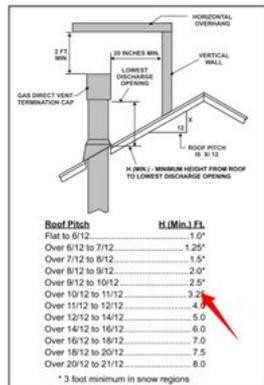
Figure 7.11 Minimum Height From Roof To Lowest Discharge Opening

The gas fireplace vent does not have the proper clearance from the roof covering per building guidelines. A qualified fireplace contractor is recommend for evaluation and repair.

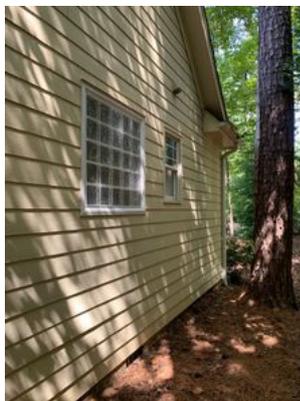
**Comment 2  
Information**

Tree roots create issues with foundations, footing and other structural elements.

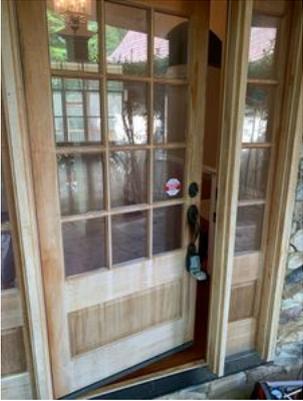
**Comment 12**  
**Information**

The front entry door needs adjustment in order for the strike to close/latch properly.

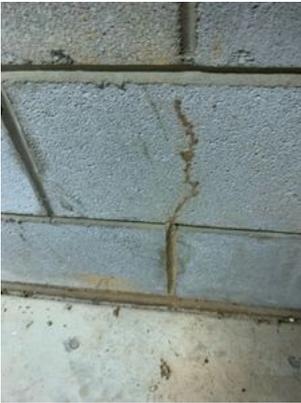
**Comment 18**

Signs of termites were visible in the garage. Contact a licensed pest company for treatment if the current owners cannot provide proof of previous treatment.

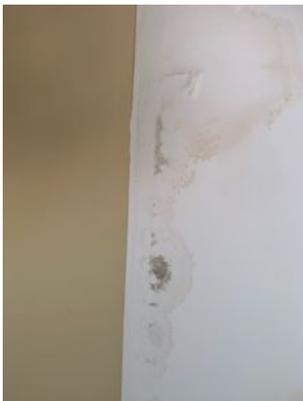
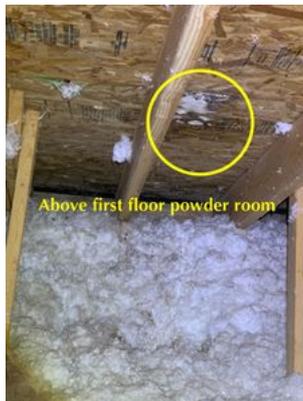
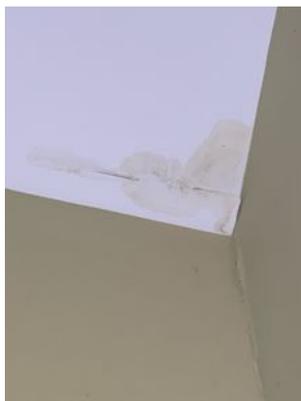
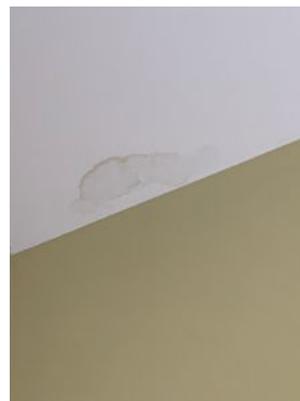
A license roofing contractor is recommended to perform a full evaluation of the roof, covering due to active leaks and multiple moisture stained areas of the ceiling observed at the time of the inspection.

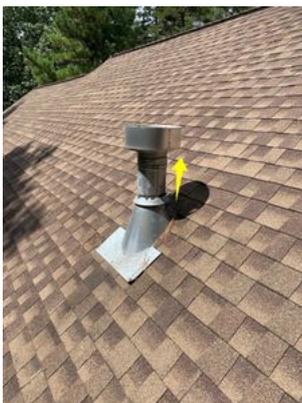
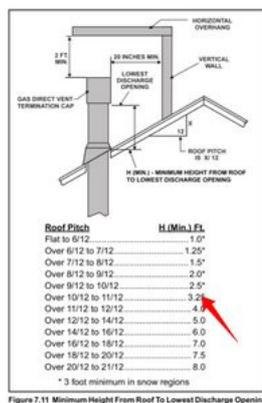
The gas fireplace vent does not have the proper clearance from the roof covering per building guidelines. A qualified fireplace contractor is recommend for evaluation and repair.

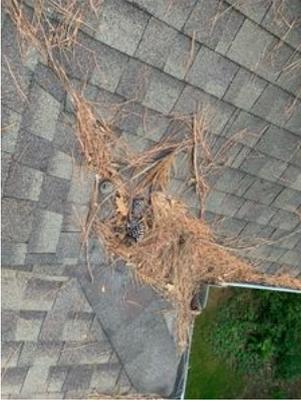
**Comment 28**  
**Information**

There was debris from trees and surrounding vegetation on the roof. This can allow water to back up under the roofing materials and could lead to water entry and damage to surrounding components. Removal of the debris is recommended.

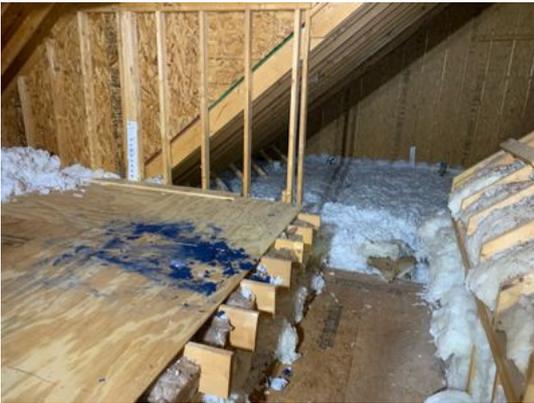
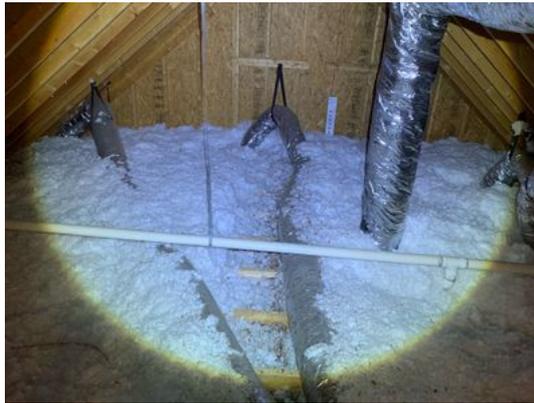
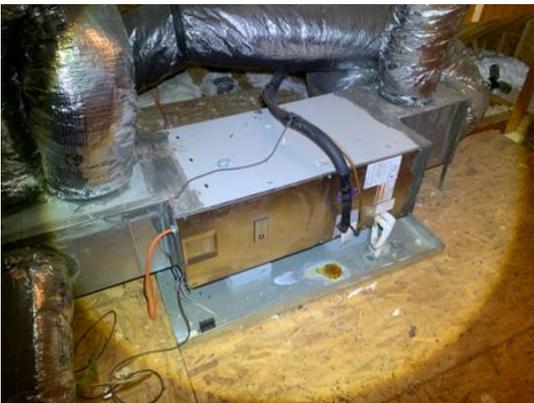
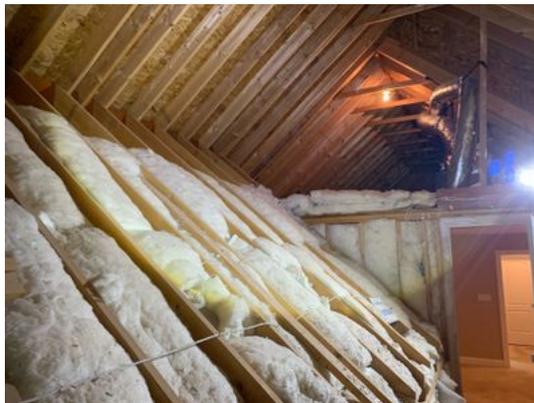
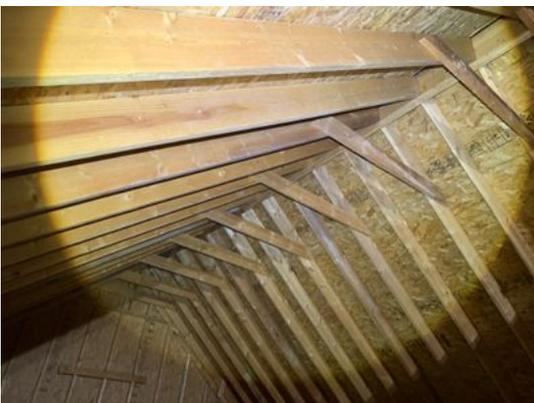
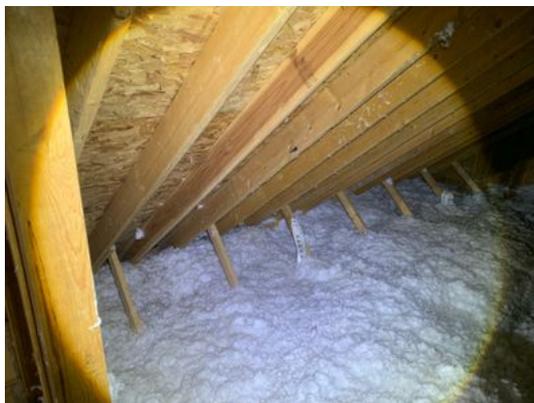
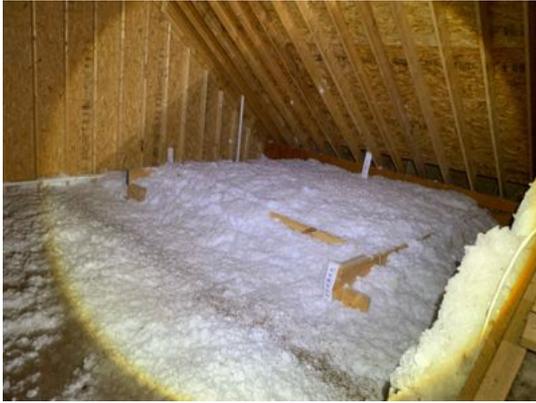
**Comment 33  
Information**

General Attic Photo(s)

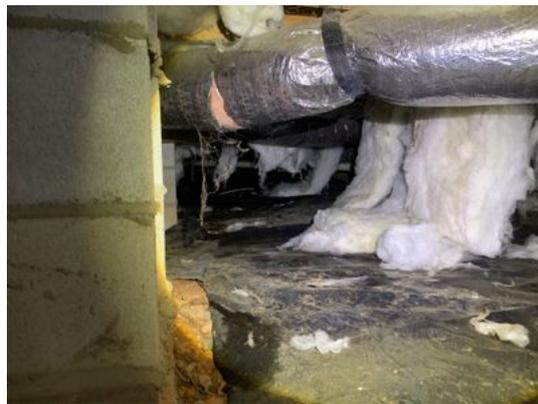
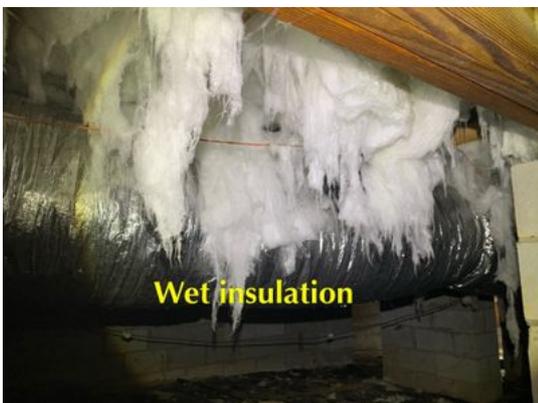
**Deficiency**

A qualified contractor is recommended to evaluate multiple areas of active water entry into the crawlspace, elevated moisture levels on the floor, structure, wet/damaged/missing insulation. An invasive evaluation is recommended to determine the extent of any moisture damage.

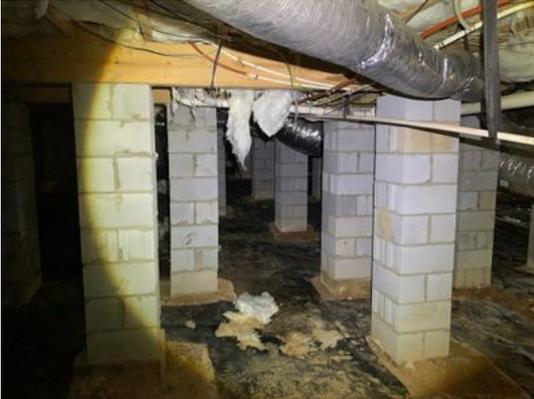
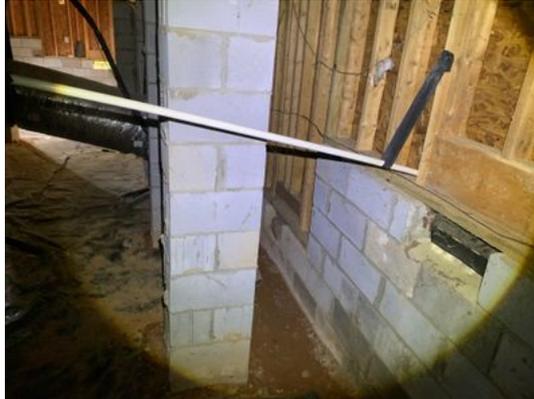
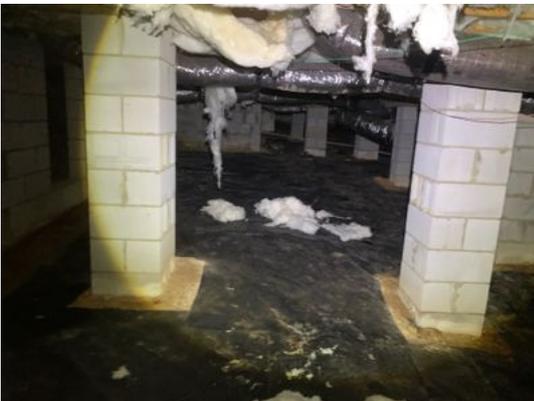
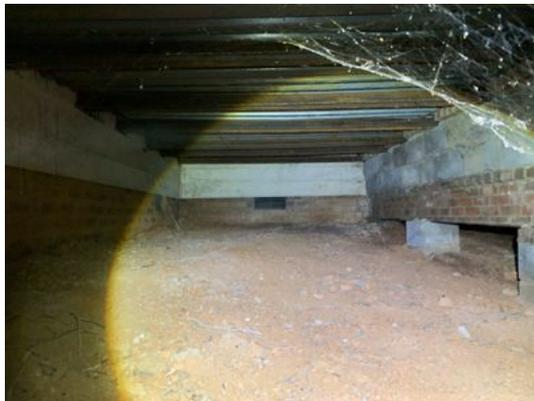
**Comment 37**  
**Information**

General Crawlspace Photo(s)
